**HERITAGE REFERENCE COMMITTEE
TO BE HELD ON THURSDAY, 28 JULY 2022 AT 12:00 PM
LEVEL 3 ANTE ROOM / ZOOM**

GB.2 **Headfort House, Stanhope Road Killara - Recommended Heritage listing planning proposal** **12**

HEADFORT HOUSE, STANHOPE ROAD KILLARA - RECOMMENDED HERITAGE LISTING PLANNING PROPOSAL

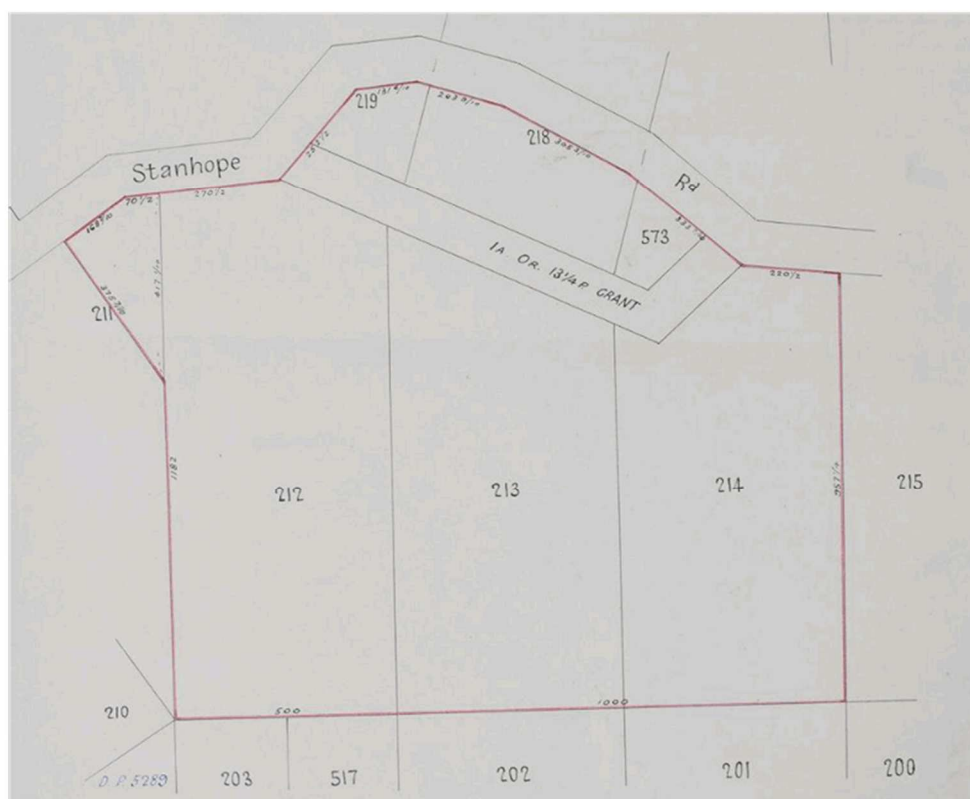
Figure 2.12 1934 plan of Congregational Union of NSW landholdings at Stanhope Road, Killara. (Source: CT 4664-126, LPI NSW)

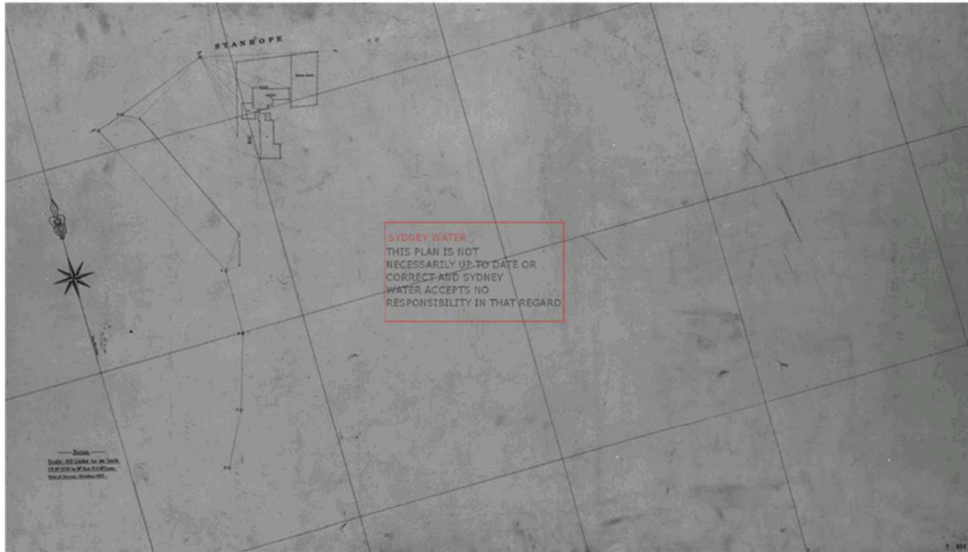
Figure 2.13 1927 Sydney Water survey of the Milton Grammar School. (Source: Sydney Water Archives)

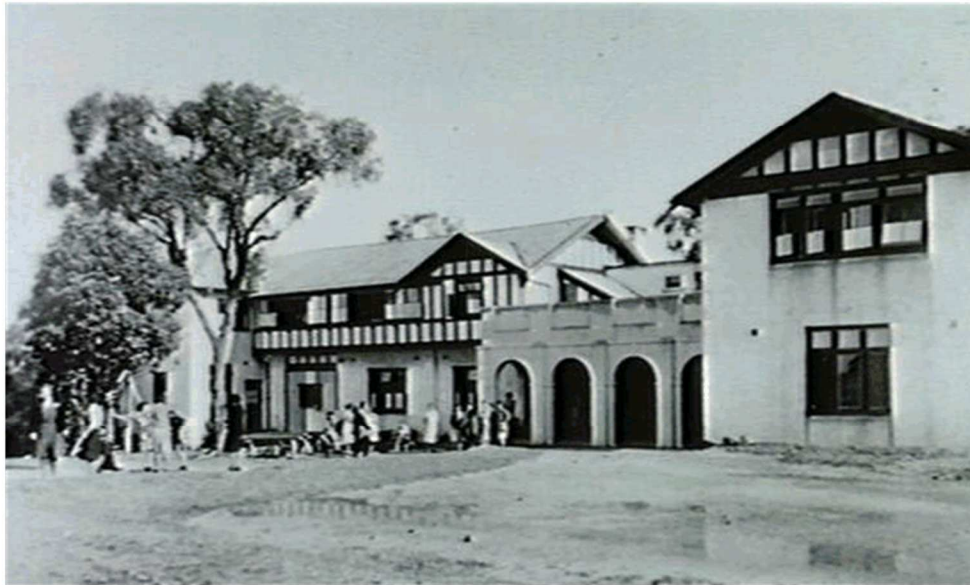
Figure 2.19 1942 view of the former school buildings, here being used by the Australian Women's Army Service. The east elevation of Headfort House is on the left. The arched structure was constructed in 1928. (Source: Australian War Memorial, viewed 22 February 2017 <<http://www.awm.gov.au/collection/P01343001>>)

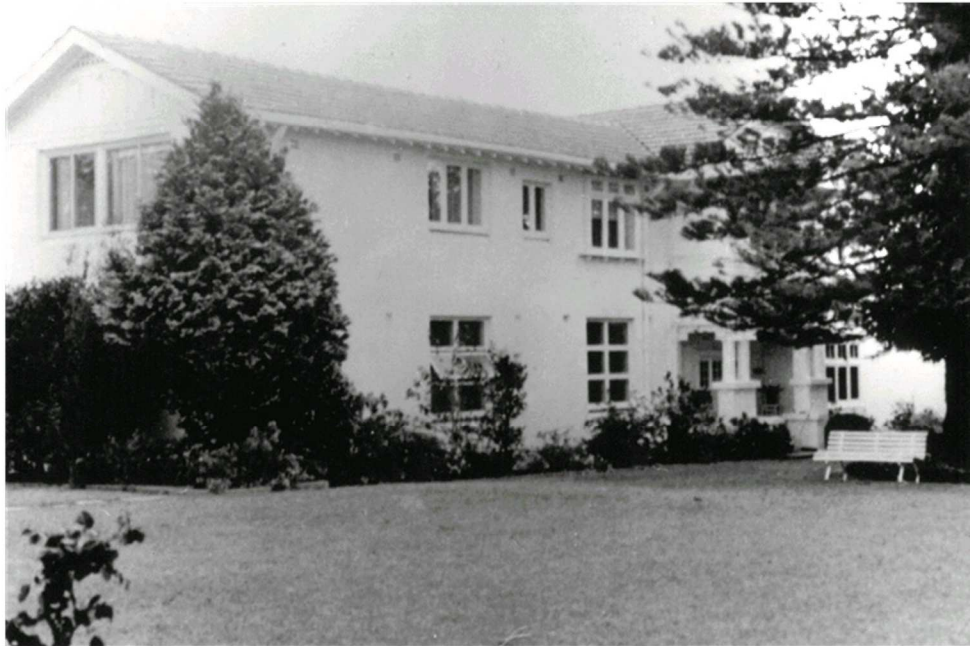
Figure 2.23 Headfort House c1950s, published in Cook, KM 1991, *The Railway Came to Ku-ring-gai*, Genlin Investments, Pymble. Note that the original windows in the chapel wing have been replaced. (Source: Ku-ring-gai Historical Society photographic collection)

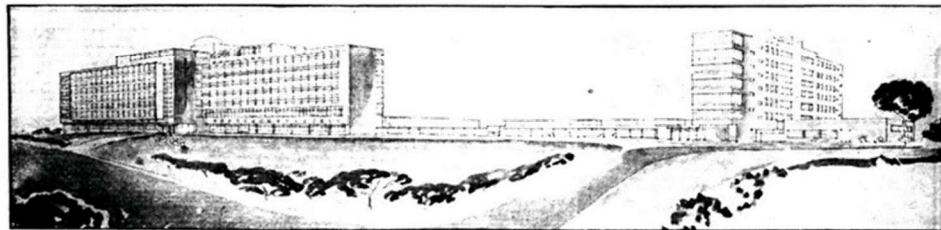
Figure 2.25 Published drawing of the proposed 250-bed hospital (not realised). (Source: *Catholic Weekly*, 12 October 1950)

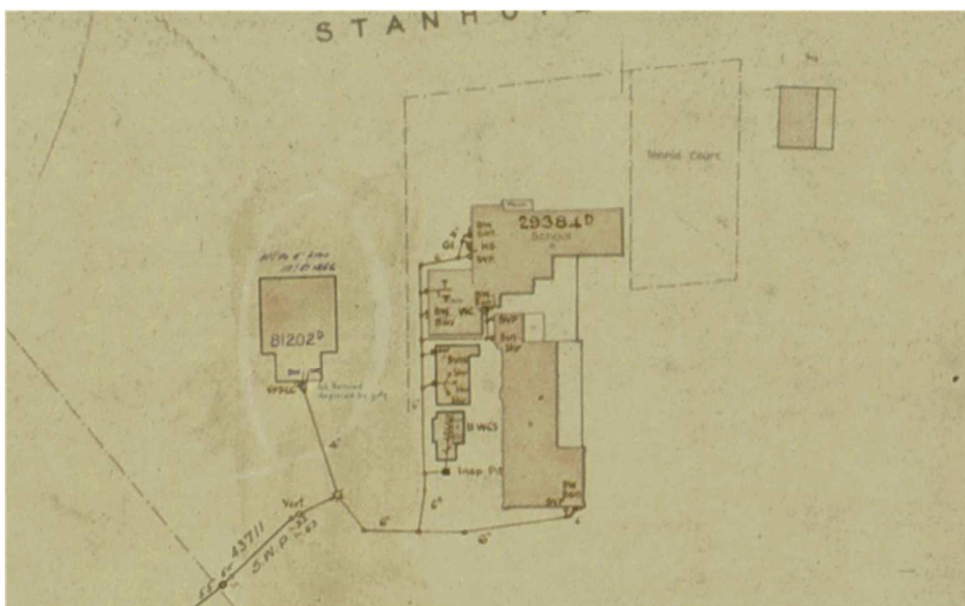
Figure 2.26 The Blackwattle Plan of the subject site, dating between 1927–c1953. (Source: Sydney Water Archives)

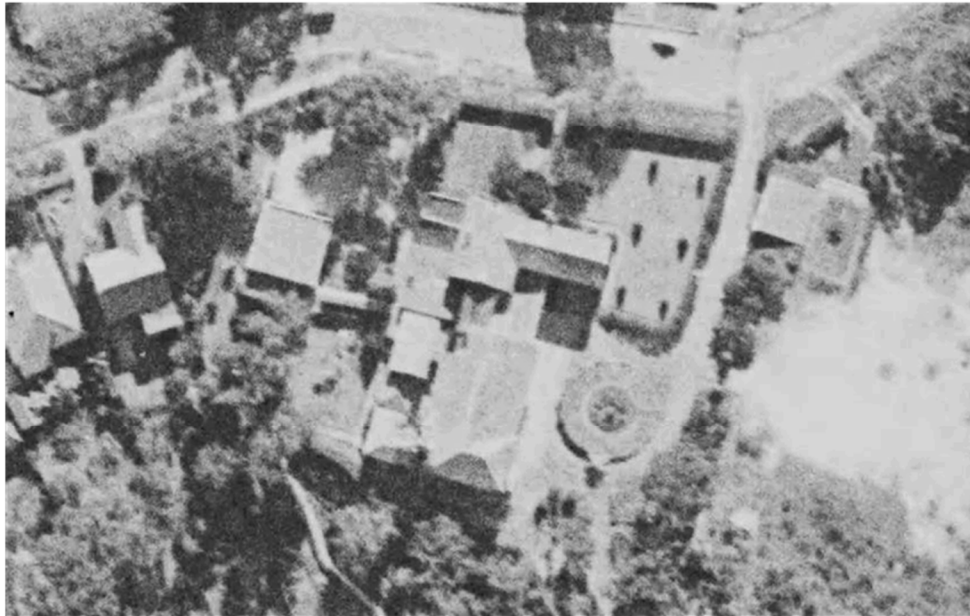
Figure 2.27 1956 aerial of the subject site showing buildings and immediate gardens, including established gardens on the tennis court, grotto and garage, of the Lourdes Hospital. (Source: LPI NSW)

shows the same buildings as the 1943 aerial of the study area with an additional building in the location of the WC (Figure 2.26). The 1956 aerial photograph shows the tennis court had become part of the gardens and a grotto had been constructed to the east of the hospital building. There was also an extension between the smaller buildings to the west of the main hospital/former school buildings (Figure 2.27).

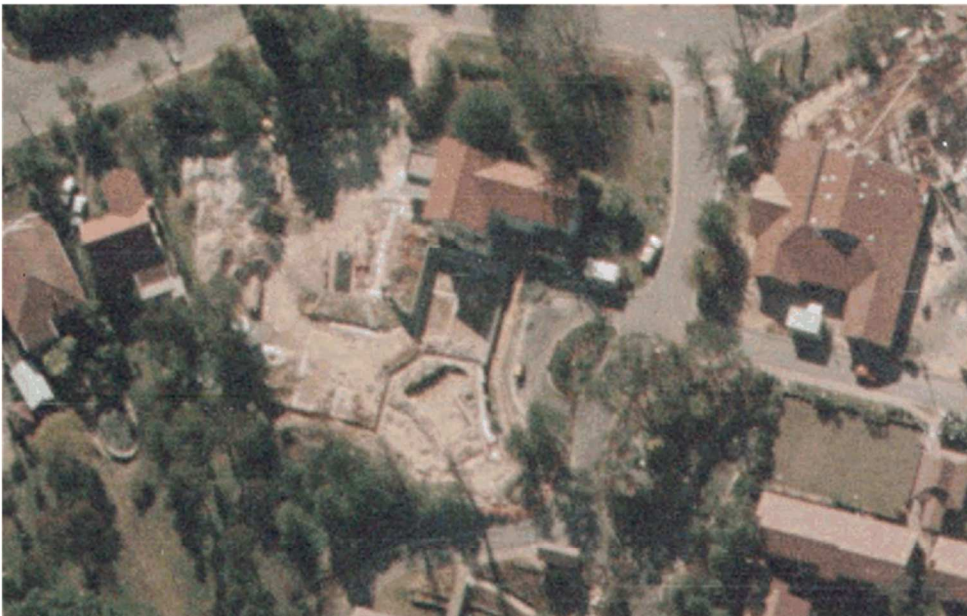
Figure 2.30 Detail of subject site on 1986 aerial showing one of the former school buildings already demolished and the footings of the new administration building. (Source: LPI NSW)

In December 1984, Aevum (then the Hibernian Society) received approval from council to construct a 44-bed nursing home on the subject site, to be called Lourdes Retirement Village (Figures 2.29 and 2.30). As part of the works, apart from the earliest school building (Headfort House), all the other earlier buildings on the site were demolished. It was most likely at this time that the Chapel wing was altered to house the retirement village's chapel, and the rear of the main part of Headfort House was altered and connected to a new building in its southern side. In July 1995, the company received approval to increase the number to 48 beds.⁴⁹ In 2011, Council approved the construction of an additional 18 self-contained units (Figure 2.31).⁵⁰

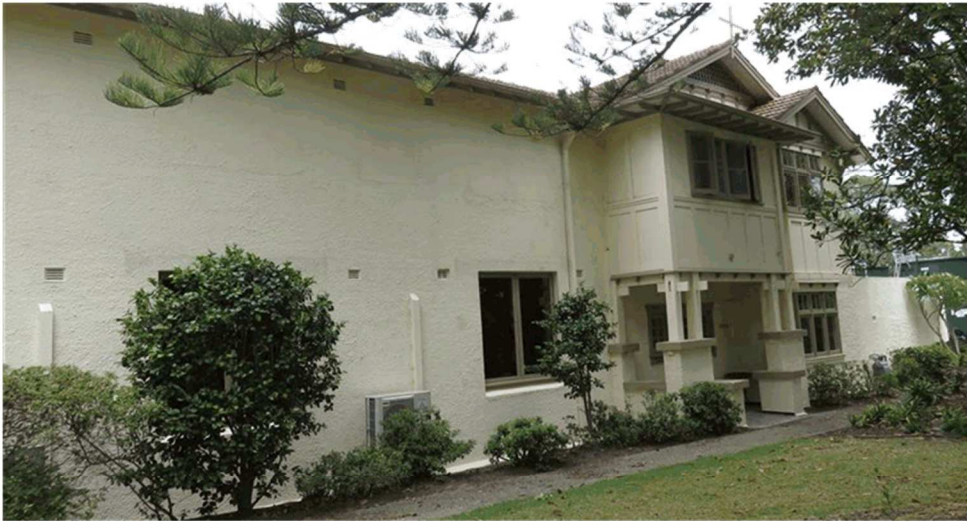
Figure 3.1 The north (front) elevation of Headfort House at 95 Stanhope Road, Killara (facing Stanhope Road), in its garden setting. (Source: GML 2017)

The front of Headfort House addresses Stanhope Road (although the main entrance to the Chapel is on the southern side of the building) (Figure 3.1). The front of the building is parallel to the roadway, and a rectangular front yard—with perimeters defined by garden beds containing hedge plants—separates the building from Stanhope Road (Figure 3.2). The front yard consists primarily of open lawns. Three mature trees are located within the front lawn area—two large Norfolk Island pine trees and a Moreton Bay fig tree, the latter surrounded by a roughly circular garden. Other planting consists of small shrubs and ground covers, generally exotic species. The extent and form of the front garden—areas of flat lawns surrounded by hedges with some planting interspersed—largely matches the 1943 aerial photograph. However, the front garden currently extends further to the east than it did in 1943, when its eastern boundary roughly aligned with the eastern wall of Headfort House. Photographs dating from the late 1920s and 1930s show the front garden’s northern and western perimeters further defined by timber post and rail fences with wire mesh infill; these fences no longer exist. On its eastern side was a fenced open area, possibly a tennis court.

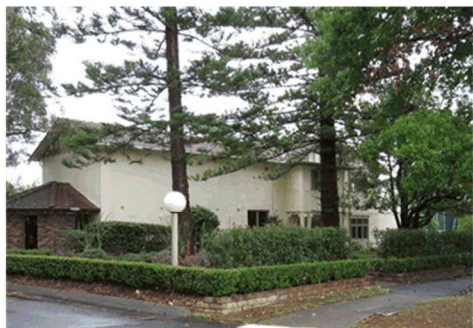
Figure 3.2 View of Headfort House from the northeast. The hedges around its front garden and large trees within the garden can be seen. (Source: GML 2017)

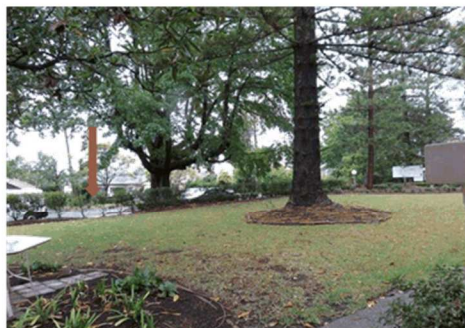
Figure 3.3 View across the front garden looking towards Stanhope Road. The gap in the garden edging at the property boundary (marked with an arrow) is likely the location of the original gateway to the property. (Source: GML 2017)

Historic photographs also show a meandering paved path through the garden leading from Stanhope Road to the front door of the building, with a branch of the path curving around to the western side of the building. Whereas this path no longer exists, a break in the (1980s?) brick garden edging on the Stanhope Road boundary is evidence of where the path was once started (the hedge plants are continuous across the gap) (Figure 3.3). The double-leaf timber joinery gates that marked the start of the path and the public entrance to the garden, as shown in a photograph from the 1930s, no longer exist. Although the three trees within the front yard are mature, only one of the pine trees appears to possibly exist in an aerial photograph dating from 1943. None of these trees appear in the 1927 photograph of the front of the building.

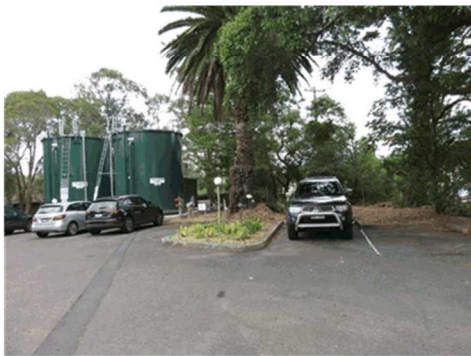
Figure 3.4 The carpark located to the west of Headfort House. (Source: GML 2017)

A driveway and small bitumen-paved carpark is located to the immediate west of the front garden and Headfort House. The carpark is bitumen paved with concrete kerb edging, possibly built c1980 (Figure 3.4). A curved concrete driveway leads to the carpark from Stanhope Road. The driveway has garden surrounds that are edged with narrow sandstone blocks (nominally 80mm thick). Dense vegetation—

mature trees and shrubs—largely screens the carpark from view from Stanhope Road to the west. Two large metal water tanks are located between the carpark and the western boundary of the site (Figure 3.4). It is not possible to tell if the driveway exists in the 1943 aerial photograph, but there was a cleared open area (possibly paved) in the location of the current carpark. To the south was located a detached building with flat or mono-pitched roof with lean-to structure on its southern side, possibly a verandah. This building no longer remains.

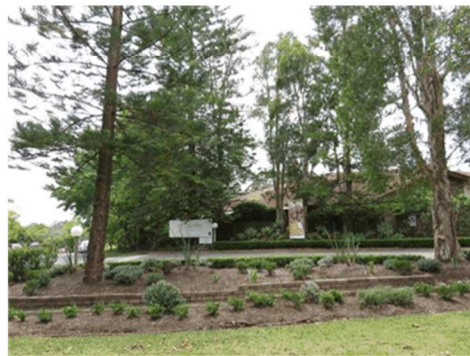
Figure 3.5 The main entrance to the LRV, as seen from the front yard of Headfort House. (Source: GML 2017)

The main entrance (vehicular and pedestrian) to the LRV from Stanhope Road is to the east of Headfort House and its front garden, where a roadway extends from Stanhope Road to a drop-off bay near the southeastern corner of Headfort House (Figure 3.5). A concrete footpath runs parallel to the roadway, through the front garden of Headfort House. Both driveway and path are most likely contemporary with the LRV complex (1980s).

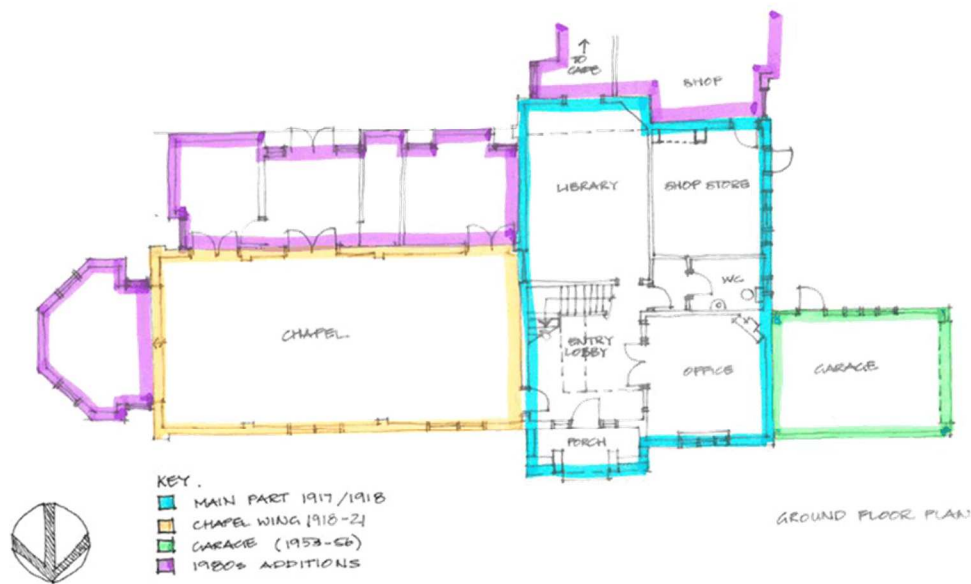
Figure 3.6 Sketch of the existing ground floor plan of Headfort House, coloured to show the construction periods of various components. (Source: GML)

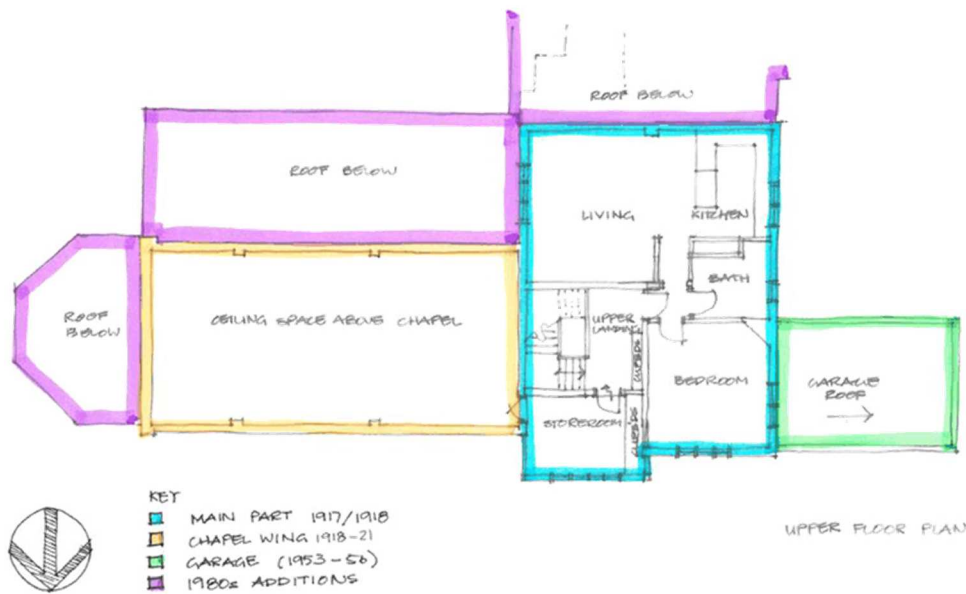
Figure 3.7 Sketch of the existing upper floor plan of Headfort House, coloured to show the construction periods of various components. (Source: GML)

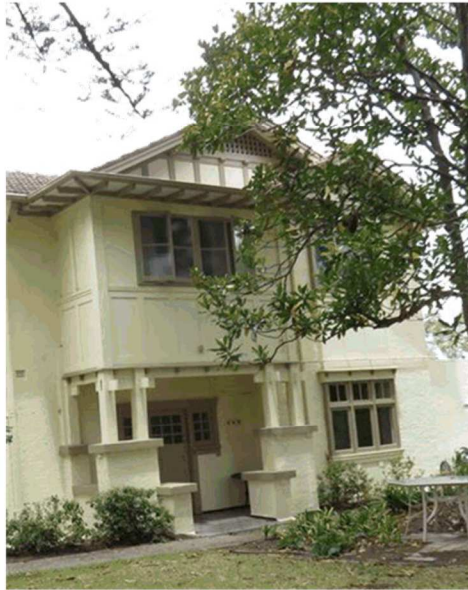
Figure 3.8 The north (front) elevation of the main part of Headfort House at 95 Stanhope Road, Killara (facing Stanhope Road), in its garden setting. (Source: GML 2017)

The north elevation of the main part of the building—its main elevation—is substantially intact, except for the enclosure of the upper floor verandah. Fenestration and timber detailing is original and is generally in good condition. However, all the original windows on the north elevation of the chapel wing have been removed and infilled, or replaced. Wall vents on the chapel wing’s north wall are however largely original.

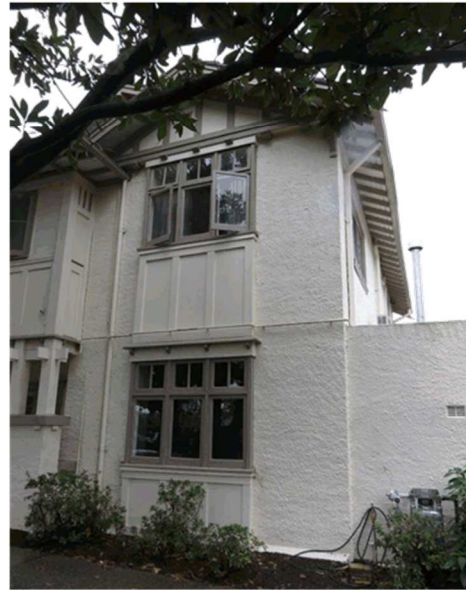
Figure 3.9 The framed wall panels below the windows on the north (front) elevation of Headfort House. (Source: GML 2017)

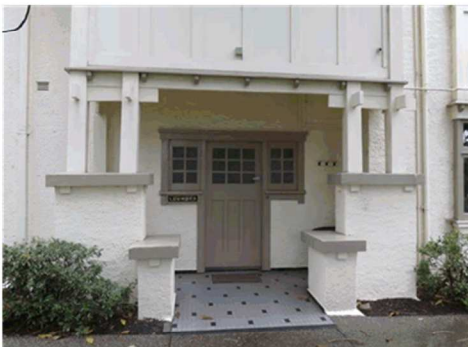
Figure 3.10 The entry porch and front door. (Source: GML 2017)

The recessed entry porch (north elevation) has two half-height stuccoed masonry piers with smooth rendered pediments and twin timber columns above (Figure 3.10). Faux projecting timber beams decorate the tops of the timber columns. The detailing of the entry porch matches the detailing visible in a 1920s photograph of the building. The soffit is timber boarded and painted, and is most likely original, although the surface mounted fluorescent light fitting is not. The floor has a slight fall away from the door, and is finished with (contemporary) tiles which extend beyond the masonry piers. It is likely that the floor of the porch has been adjusted to be slightly ramped in order to remove the step at the edge of the porch which can be seen in the c1930 photograph. There is a timber electrical box mounted high on the wall of the porch.

The front door is a high-waisted timber joinery door, with obscure glazing to its upper portion, divided into nine equal panes (Figure 3.10). Side-lights exist on both sides of the door, each with six equal panes. The door and sidelights appear to be original. The door and sidelights feature obscure patterned glass, a single type used throughout. The door has a contemporary stainless steel lever and lock.

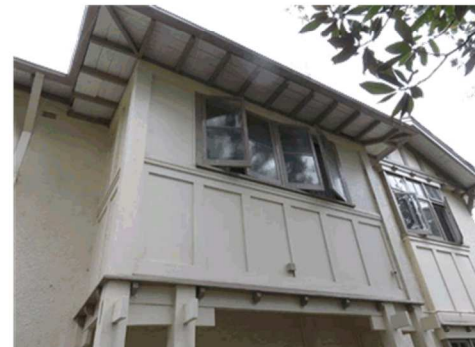
Figure 3.11 The verandah above the entry porch. The windows are a later addition. (Source: GML 2017)

Directly over the entry porch is a projecting framed structure that was originally built as a semi-recessed verandah, but which has now been enclosed (Figure 3.11). Walls are framed and clad with fibrous cement sheet to about one metre in height and feature expressed vertical timber battens, these being the original balustrades around the verandah. Above the balustrade level the original opening on the northern wall has been infilled with timber framed windows with casement sashes. There is a flat roof over the former verandah, with wide projecting eaves that are timber boarded with expressed timber rafters. The verandah structure remains substantially as originally built, except for the insertion of the timber framed window.

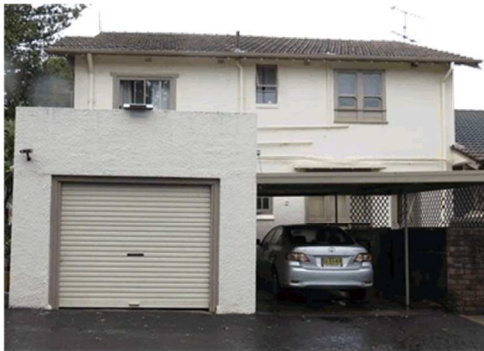
Figure 3.12 The west elevation of Headfort House. (Source: GML 2017)

The west elevation was designed as a secondary elevation, and is not as detailed as the north elevation (Figure 3.12). Masonry walls are stucco and paint finished. Eaves are timber boarded and raking with expressed timber rafters, matching those on the other elevations. The sandstone foundations are also visible on the western elevation.

There are three upper floor windows. The window near the northern corner—aluminium framed with sliding sashes—is a later addition; early photographs show no windows in this location. The central window is an awning window, which is most likely a replacement for an original window in the same

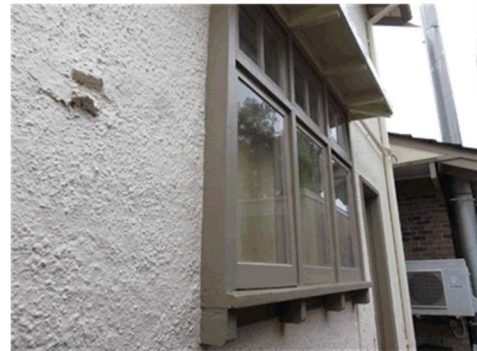
Figure 3.13 Detail of the large timber framed window, west elevation. (Source: GML 2017)

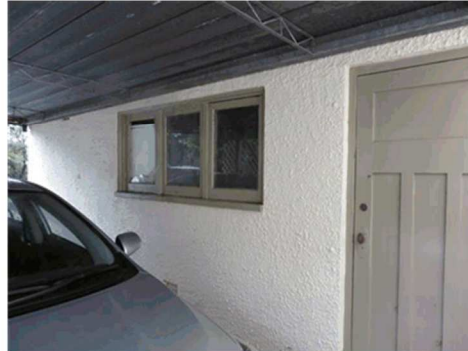
Figure 3.15 The south elevation of the garage, with door and window that are likely to have been salvaged from elsewhere on the site. (Source: GML 2017)

The garage is a single-storey masonry structure attached to the western elevation of Headfort House, close to its northern corner. Aerial Photographs and plans indicate that the garage is a later addition to the building, built between 1953 and 1956. The garage's external walls are stucco and paint finished, and extend up to form a parapet on three sides (Figure 3.14). The metal deck roof has a low pitch, and falls to a box gutter adjacent to the western wall. There is a metal roller door (contemporary) on its western elevation, and a single leaf door and window on its southern elevation. The door is a high-waisted timber joinery door with three lower panels, matching the door to the main bedroom; it has most likely been salvaged from elsewhere on the site and reused here (Figure 3.15). The small timber window has three equal casement sashes. It is also possibly salvaged from elsewhere on site: a similar window can be seen in early photographs on the north elevation of the chapel wing (which is no longer in place). There is steel framed carport lean-to on the southern side of the garage (late twentieth century).

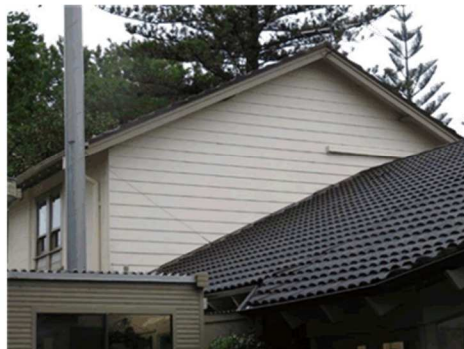
Figure 3.16 The boarded gable is the only part of the south elevation of the main part of the building that is visible. The brown tiled roof in the foreground is part of the 1980s building. (Source: GML 2017)

Due to the adjacent 1980s building on the southern side, only the upper wall of the south elevation is visible. This part of the wall is clad in fibrous cement planks. Eaves are sheet lined. There alterations are recent, and relate to the construction of the 1980s building. No original detailing is visible (Figures 3.16, 3.17).

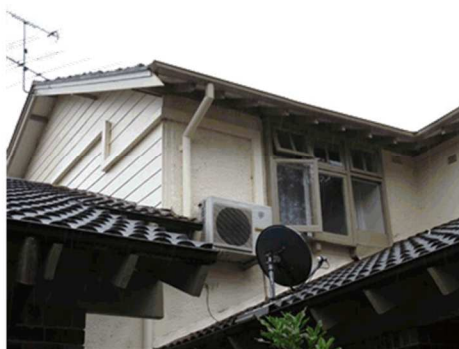
Figure 3.17 The original timber window that exists in the upper part of the east elevation of the main part of the building. The boarded gable of the south elevation can be seen on the left. (Source: GML 2017)

Only a small portion of the east elevation is visible, that being the upper floor external wall above the 1980s single storey additions to the Chapel wing. This wall is stucco and paint finished. The one window in this wall—timber framed, with three lower casement sashes and three upper awning sashes—matches those windows on the north and west elevations, and is most likely original (Figure 3.17).

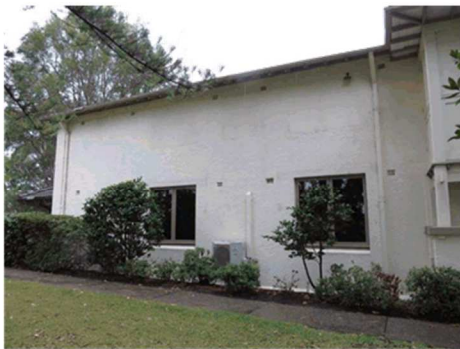
Figure 3.18 The north (front) elevation of the chapel wing. 'Shadows' of former window openings can be seen in the stucco finish. (Source: GML 2017)

The chapel wing has masonry external walls with painted stucco finish, built on sandstone footings (visible on the north elevation). The pitched roof is tiled, and eaves are timber boarded with expressed timber rafters. A comparison of the building's current condition with early external photographs indicate that the overall size and form of the wing remains unchanged, although there have been changes to the wing's fenestration. Discontinuities in the stucco finish on the north and east walls indicate that several upper floor windows have been removed and the openings infilled—three windows on the north wall and one window on the east wall. On the north elevation, the two timber framed windows that currently exist on the ground floor have contemporary detailing, and are not original, although the location of these windows approximates the location of original window openings. There are three rows of terracotta wall vents on the north elevation which match those visible in early photographs (Figure 3.18).

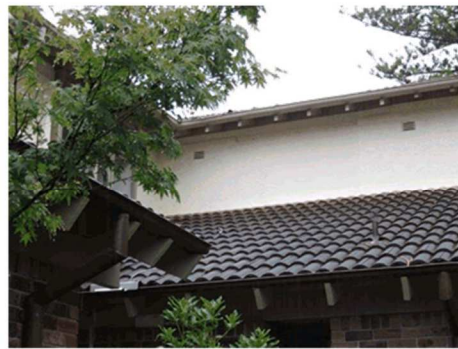
Figure 3.19 The upper part of the wall of the chapel wing can be seen above the 1980s tiled roofs. (Source: GML 2017)

Most of the southern elevation is concealed by 1980s additions (Figure 3.19). However, 'shadows' in the stucco finish indicate upper floor openings that have been infilled. A row of high level wall vents remains, which match those on the northern elevations.

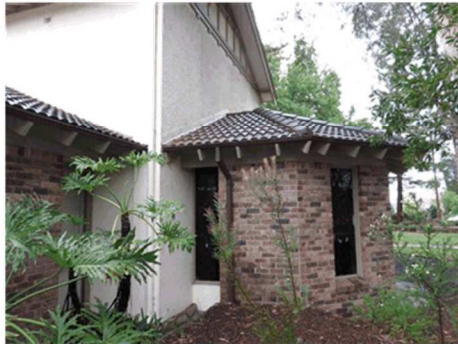
Figure 3.20: The 1980s addition on the eastern side of the chapel wing. (Source: GML 2017)

Single storey 'lean-to' additions were constructed in the 1980s on the southern and eastern sides of the Chapel (Figure 3.20). These additions have face brickwork external walls and hipped dark brown glazed tiled roofs with raking eaves with exposed timber rafters, matching the larger 1980s building located on the south side (and connected to) Headfort House.

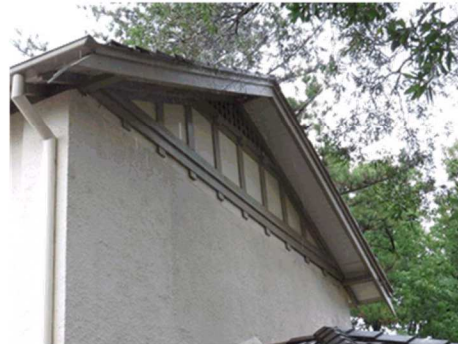
Figure 3.21 The eastern gable of the chapel wing. The shadow in the stucco below shows the location of the window that was originally located in this wall. (Source: GML 2017)

The eastern gable is finished in fibrous cement sheet with exposed timber battens and decorative timber trims. Battens are arranged in a lattice pattern at close to the ridge. This corresponds with the gable detailing that can be seen in early photographs. It also matches the detailing of the main gable on the north elevation (Figure 3.21).

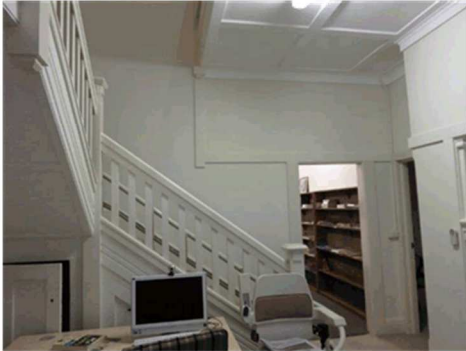
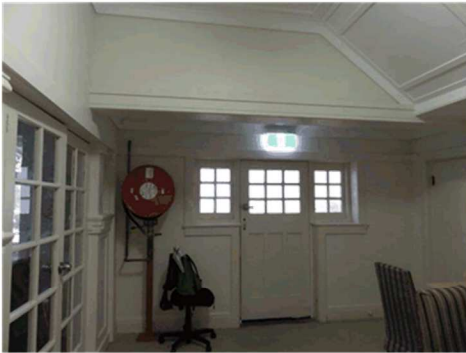
Figure 3.22 The entry lobby, looking towards the southern wall. (Source: GML 2017)

Figure 3.24 The north wall of the entry lobby, with front door and sidelights. (Source: GML 2017)

The entry lobby retains its original layout and proportions, and timber detailing is largely intact (Figures 3.22–3.25). Walls are smooth set and painted, and floors framed and carpeted. Skirtings are 150mm high with curved top edge: these are used consistently throughout the building and appear to be original. The ceiling is sheet-lined and batted with profiled plaster cornice. A simple timber batten rail runs around the walls at door-head height. An original window/hatch under the stair has been blocked in, but the recess and timber surrounds remain intact. A small timber joinery door gives access to the storeroom under the stairs.

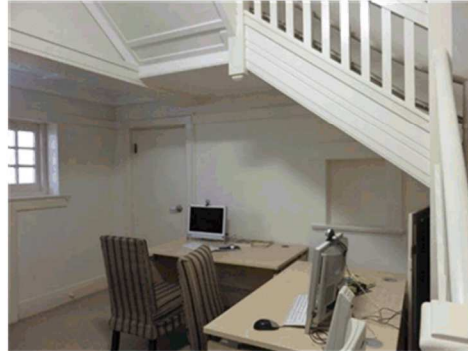
Figure 3.23 The east wall of the entry lobby, with door to the chapel. (Source: GML 2017)

The single leaf door leading to the chapel (timber frame, flush door) is not original (Figure 3.23). The doorway to the office has elaborate built-in joinery at its sides, but the glazed door leafs themselves are not original, and there are signs that indicate that the opening has been adapted to accommodate these door leafs (Figure 3.25). The stair is timber framed with timber newel posts and handrails most likely original. The grooved stair rails appear to be more recent however, and perhaps relate to the installation of the chair lift that runs on the inside face of the balustrade. It is unclear if other parts of the balustrades are also recent replacements for original components.

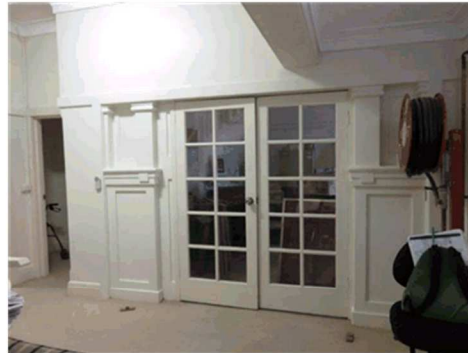
Figure 3.25 The door to the office, as seen from the entry lobby. (Source: GML 2017)

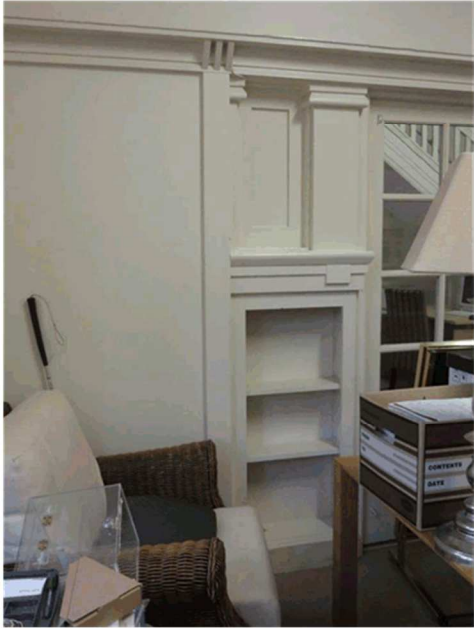
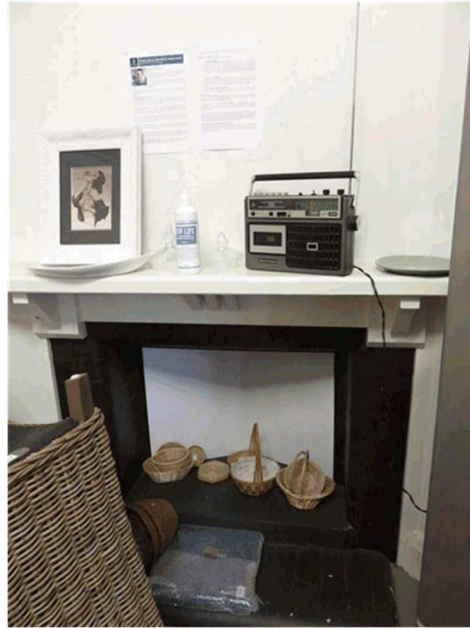
Figure 3.26 The timber joinery adjacent to the door of the office. (Source: GML 2017)

Figure 3.27 The fireplace in the office. (Source: GML 2017)

The floor of the office consists of tongue and groove timber boards with carpet finish. The walls and ceiling are smooth set and the room's plaster cornices and timber skirtings match those in the entry hall. A grooved timber rail runs around all walls at door head height. Built-in timber joinery fixtures, consisting of open shelves and other decorative features, frame the door on either side (Figure 3.26). The built-in timber window seat/storage box is a later addition. There is a fireplace in the southwestern corner with painted brick hearth and surrounds, and a timber mantelpiece (Figure 3.27). The style of the timber joinery in the space is consistent with the Arts and Crafts style, although it is unclear if the grooved timber wall rail is original. Two gridded wall grilles are located at high level in the western wall.

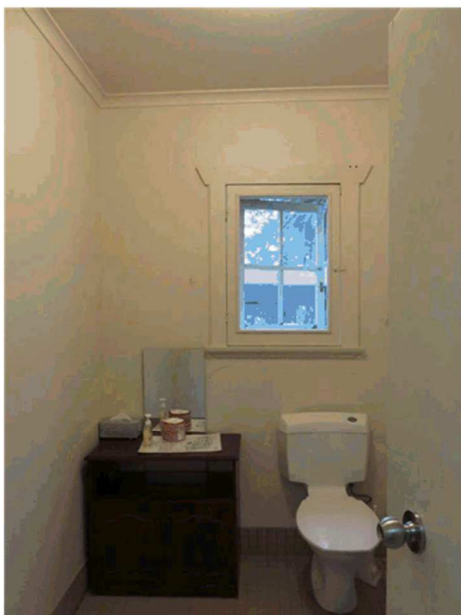
Figure 3.28 The bathroom: the window is original, but fixtures and fittings in the room are contemporary. (Source: GML 2017)

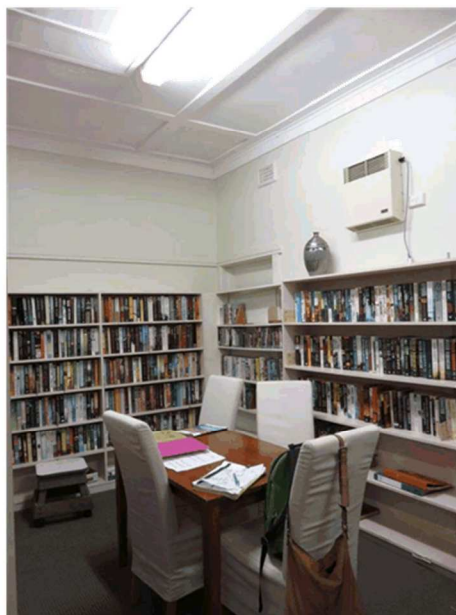
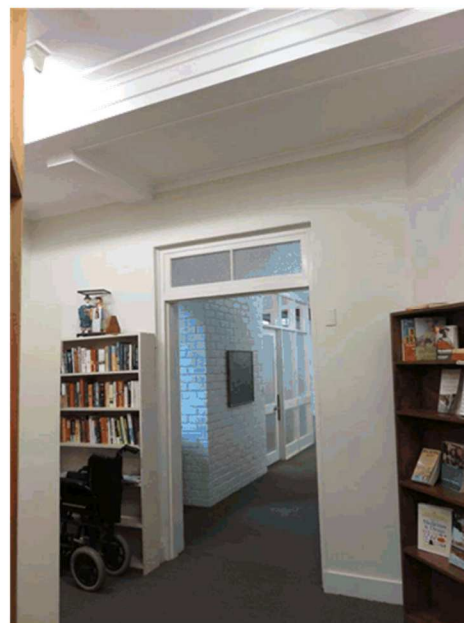
Figure 3.29 The library, looking towards the northeastern corner. The former doorway to the chapel can be seen behind the bookshelves. (Source: GML 2017)

Figure 3.31 The doorway in the southern wall that leads to the 1980s building. (Source: GML 2017)

The library is legible as a single large room, even though it is partly subdivided by a glazed screen wall which is a contemporary addition (Figures 3.29–3.31). It has a framed floor with carpet finish, smooth set walls and a smooth set ceiling with battened detail. The room's plaster cornices and ceilings match those in the entry hall and are most likely original. There is a lower section of ceiling adjacent which is not original (with small coved cornices), and its form and finishes are likely to relate to the 1980s building connection. Parts of the room have a timber skirting which matches that in the entry lobby. At the southern end of the room there is a wide opening which allows access into the 1980s building adjacent (Figure 3.31). This has a timber door frame and highlights with obscure glazing, but no doors. On the northern wall is an opening with timber frame leading to the entry lobby, but again there is no door leaf. Both of these doorways are likely to be original. On the eastern wall there is a blocked-in doorway that previously led to the chapel, and it is unclear if this opening is original (Figure 3.29). On the eastern wall at high level are two air grilles that match those in the office, and are original. In the southwestern corner the splayed wall is suggestive of a chimney breast. Bookshelves placed hard against this wall indicate that even if a fireplace remains behind the shelves, no protruding mantelpiece or hearth remains.

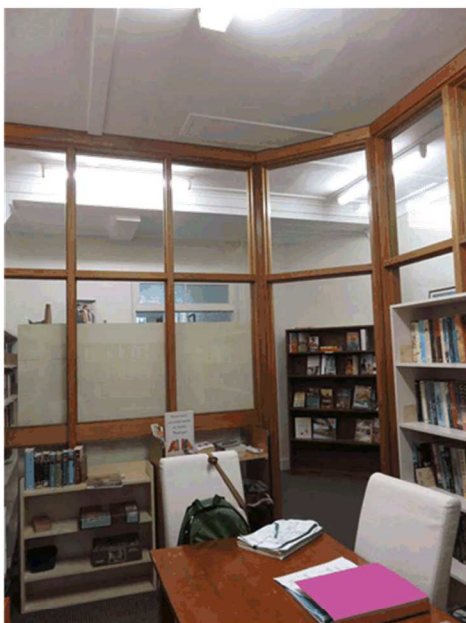
Figure 3.30 The contemporary glazed screen wall that divides the room. (Source: GML 2017)

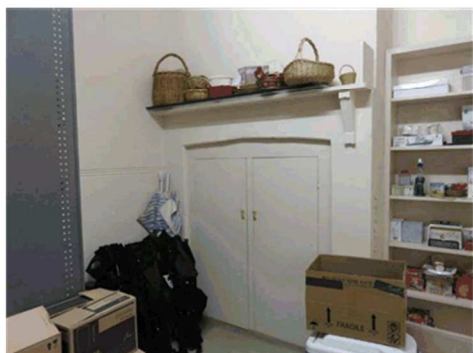
Figure 3.32 The former cooking hearth in the southeastern corner of the shop store. (Source: GML 2017)

The shop store is accessible from the shop, which is located in the 1980s building. The shop store was likely to have originally been a kitchen; there is a large former cooking hearth in the southeastern corner (Figure 3.32). The former hearth now contains a built-in cupboard, but the original timber mantelpiece remains above. Floors are vinyl sheeted (1980s?) with coved vinyl skirtings. The floor is framed, except for a large concrete section close to the cooking hearth, the extent of which is defined by cracking in the vinyl floor sheeting. Walls are smooth set, with a dado line formed in the plaster that extends around the room. Ceilings are smooth set and without any cornice. The two doors into the room are flush doors. The door that led to the shop is a new opening. The doorway to outside is possibly an early or original opening, but the door leaf is new (Figure 3.33).

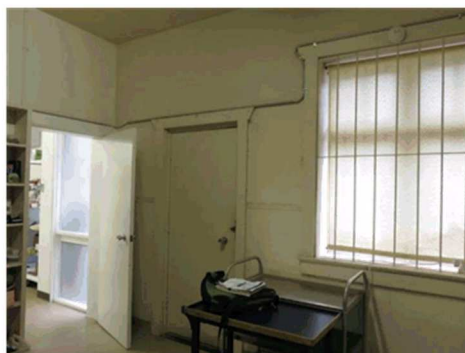
Figure 3.33 The southeastern corner of the shop store. The door on the right leads outside. (Source: GML 2017)

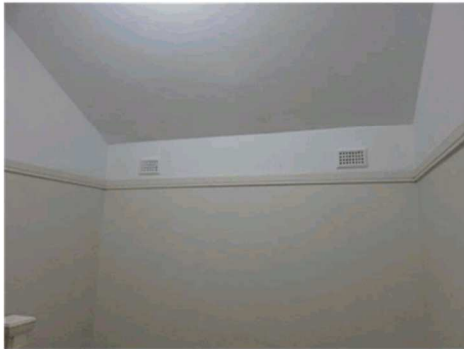
Figure 3.34 The upper part of the eastern wall of the upper landing, above the stair. The air grilles suggest this was originally an external wall. (Source: GML 2017)

The upper landing is a large circulation space at the top of the stair that leads from the entry lobby. Both the stair and upper landing have carpeted framed floors. Walls and ceilings are smooth set, and the ceiling is raking above the stair. There are no cornices, but two air vents exist at high level on the eastern wall above the stair; the air grilles suggest that this wall was originally an external wall, and that the chapel wing was a later addition (Figure 3.34). The raking ceiling, which rakes downwards to the east, suggests that the roof over the stairwell originally raked in the same line as the ceiling. This adds weight to the suggestion that the hipped junction of the chapel wing's roof was constructed after the roof over the main part of the building was completed.

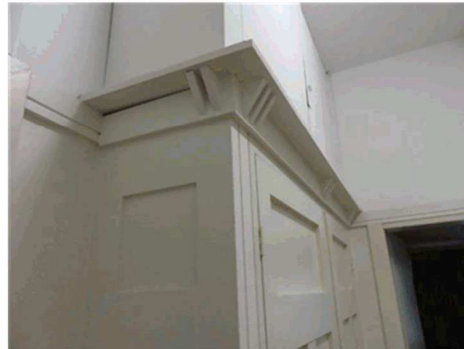
Figure 3.35 The joinery unit in the upper landing, which appears to have been relocated from elsewhere in the building. (Source: GML 2017)

A grooved timber rail runs at door head height around the walls. Skirtings are original on the eastern wall (stair rails) and northern walls, but a different profile skirting has been used on the other walls. On the western wall is a timber joinery cupboard, the upper portion of which is clearly contemporary. The lower portion (up to door head height) is detailed to match other original timberwork in the house, and is most likely original, although it has been relocated from elsewhere; the timber rail on the wall runs along the wall behind the cupboard (Figure 3.35). The timber balustrade at the landing has been replaced, although the newel posts are original.

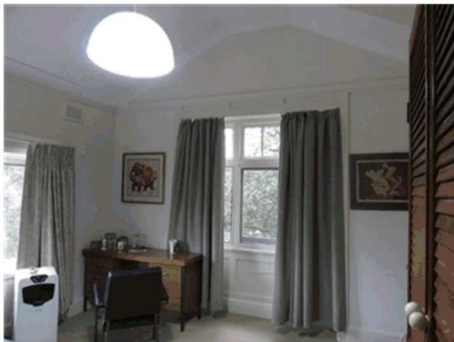
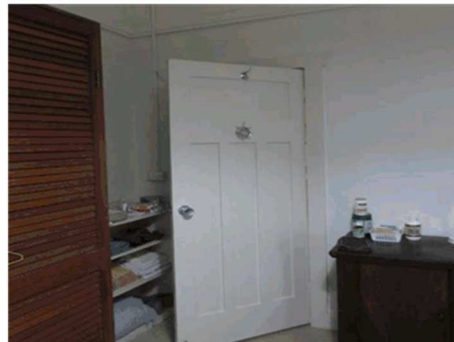
Figure 3.36 The wall of the bedroom. (Source: GML 2017)

Figure 3.37 The original door into the bedroom. (Source: GML 2017)

The bedroom has a framed floor with carpet finish (Figures 3.36, 3.37). Walls and ceilings are smooth set, with the ceiling partly raking. Cornices are contemporary covered plaster cornices. Timber skirtings match those in the entry hall, and a grooved timber rail runs around all walls at door head height. The aluminium-framed window in the western wall is of recent construction, but the door appears to be original—the door leaf is a high-waisted timber joinery door, and the door frame is timber (Figure 3.37). Door hardware is however contemporary. Below the window on the northern wall the framed wall has expressed timber battens, matching the external detail (Figure 3.36). The small hall adjacent to the bedroom matches the bedroom in finishes, skirtings and rails. However, unlike the bedroom it has no cornices.

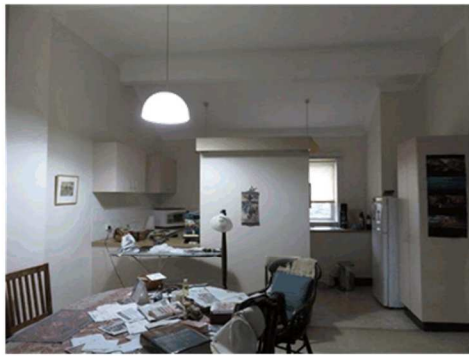
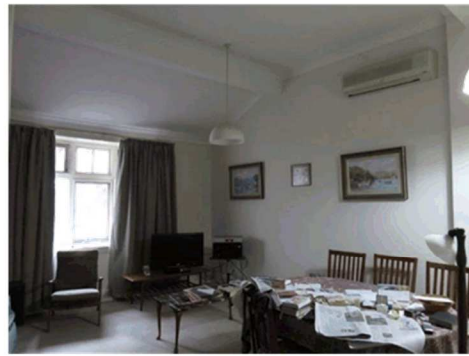
Figure 3.38 The living room, looking west towards the kitchen. (Source: GML 2017)

Figure 3.39 The southeastern corner of the living room. (Source: GML 2017)

The living room and kitchen are located within a single large room at the southern end of the building (Figures 3.38–3.39). Floors are framed with carpet or sheet vinyl finish. Walls and ceilings are smooth set. The ceilings are partly raking, and have contemporary plaster coved cornices. Skirtings are contemporary, as are all fixtures and fittings. The timber window in the eastern wall is original and matches other windows in the building.

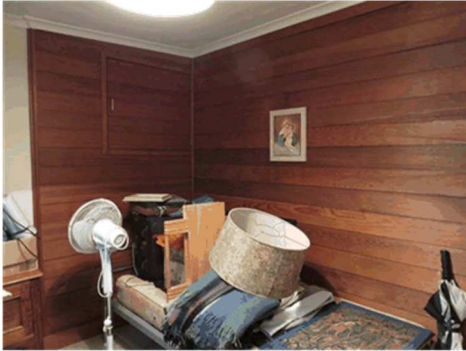
Figure 3.40 The cedar boarding on the south and east walls of the storeroom. The small door in the panelled wall gives access to the chapel's ceiling space. (Source: GML 2017)

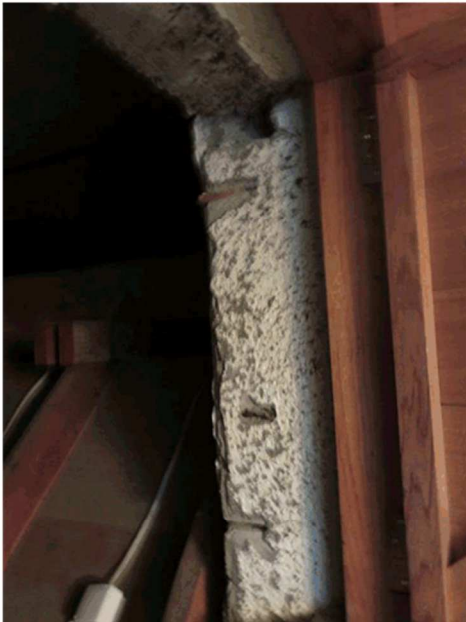
Figure 3.42 When opened the access door allows for views of the building's original external stucco finish and the space above the ceiling of the chapel. (Source: GML 2017)

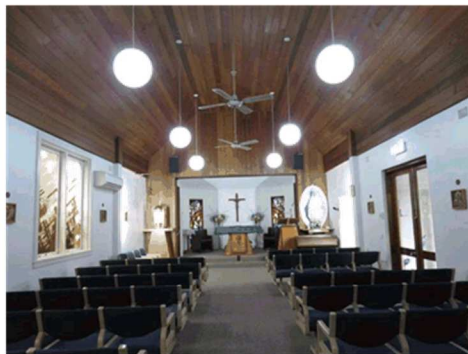
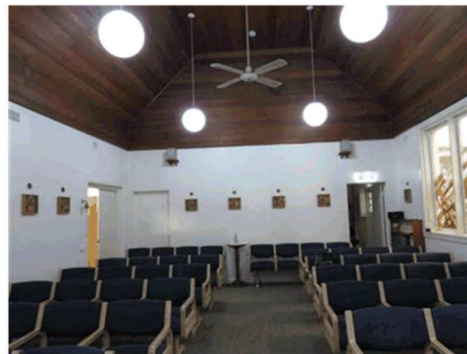
Figure 3.43 The chapel, looking east. (Source: GML 2017)

Figure 3.44 The chapel, looking west. (Source: GML 2017)

The chapel is a double-height space occupying the whole of the chapel wing (originally the chapel wing had two storeys within the same volume of space) (Figures 3.43–3.46). The floor is framed with carpet finish. Walls are generally smooth set, although western red cedar boarding has been used as a lining on the eastern wall, and upper sections of the northern, southern and western walls. These walls also feature high level air grilles at regular intervals. ‘Shadows’ in the wall plaster suggest a horizontal dado once ran around the room at about 1200mm above floor level. The ceiling is partly raking, and is lined with cedar boards to match those used on the walls. Narrow piers are located on the northern and southern walls, their uppermost portion also lined in cedar boards. These piers have slightly rounded corners for most of their height, but transition to sharp square corners at high level (Figure 3.45). Doors and windows into the room are contemporary, as are all fixtures and fittings.

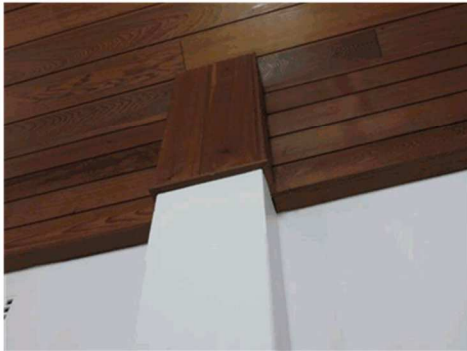
Figure 3.45 A typical wall pier in the chapel. (Source: GML 2017)

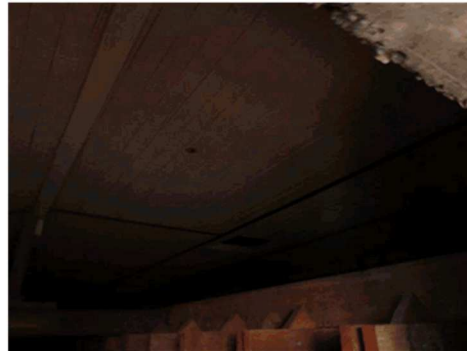
Figure 3.46 The original boarded ceiling remains above the newer cedar ceiling in the chapel. The dark lines possibly indicate the former location of walls. (Source: GML 2017)

The Chapel wing has lost much of its integrity internally. The upper floor has been removed, and a new double-height space created. No original doors, windows, fixtures or fittings remain. A new cedar ceiling and wall linings have been installed, although the original boarded ceiling of the original upper floor remains intact above the new ceiling, and in good condition.

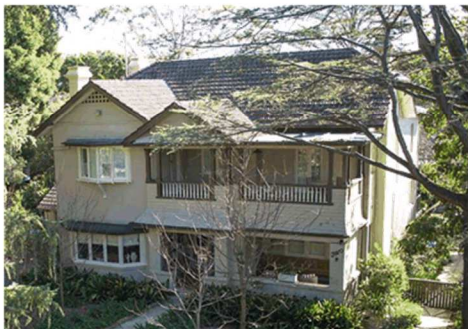
The house at 2 Stanhope Road, Killara (a heritage item listed on the Ku-ring-gai LEP 2015), is an Arts and Crafts style two-storey masonry building. Like the Chapel, the building has steeply pitched tiled roofs, double gables with lattice detail, and features timber columns on a masonry base around the upper verandah. The verandah has a flat roof similar to that of the verandah of Headfort House. However, its detailing is more refined than that of Headfort House, and includes bay windows and a timber shingle skirted balustrade.

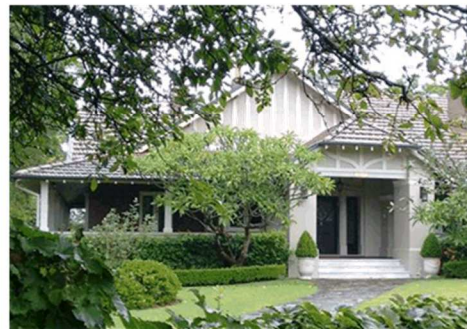
The house at 49 Springdale Road, Killara (not listed as a heritage item), has steeply pitched tiled roofs, timber battened detailing to its gables, and a defined covered entry porch slightly proud of the main building—all Arts and Crafts style characteristics that are in common with Headfort House.

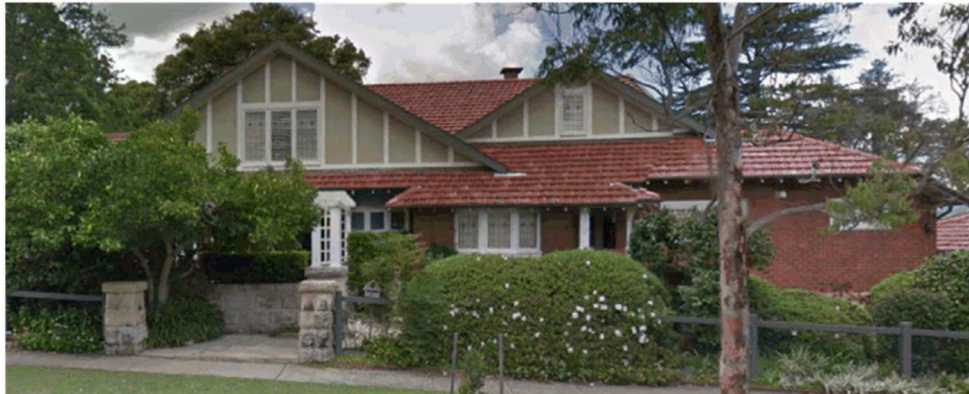
The house at 77 Arnold Street, Killara (not listed as a heritage item) has pitched tiled roofs with boarded gables, and expressed timber rafters on its eaves. Large and small roof gables have been used to affect the composition of the street elevation of the house.
