**HERITAGE REFERENCE COMMITTEE
TO BE HELD ON THURSDAY, 28 JULY 2022 AT 12:00 PM
LEVEL 3 ANTE ROOM / ZOOM**

GB.2 **Headfort House, Stanhope Road Killara - Recommended Heritage listing planning proposal** **12**

HEADFORT HOUSE, STANHOPE ROAD KILLARA - RECOMMENDED HERITAGE LISTING PLANNING PROPOSAL

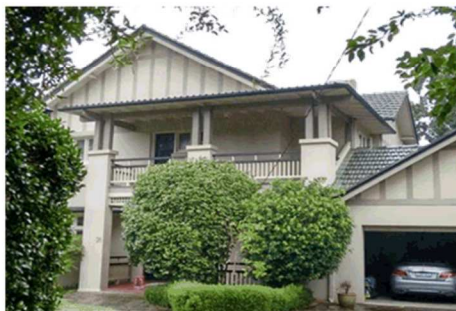
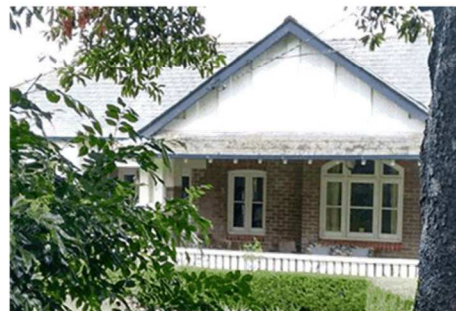
There are several houses in Springdale Road that display characteristics of the Arts and Crafts style. Steeply pitched roofs and boarded gables are common features to these houses. The house at 26 Springdale Road also has a flat verandah roof with double timber columns, similar in detail to the entry porch of Headfort House. The single storey house at 24 Springdale Road (listed as a heritage item of local significance) also has a boarded front gable. The front features timber half columns on a heavy masonry base, similar to the detail used on Headfort House.
