**10 Park Crescent, Pymble**  
**Heritage Assessment**

Prepared for  
Ku-ring-gai Council

October 2022 • Issue A  
Project number 220102

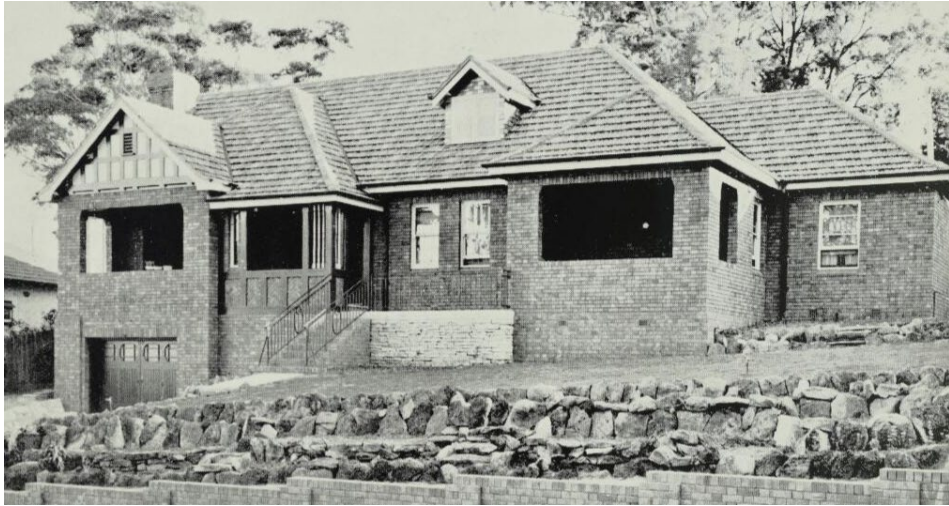
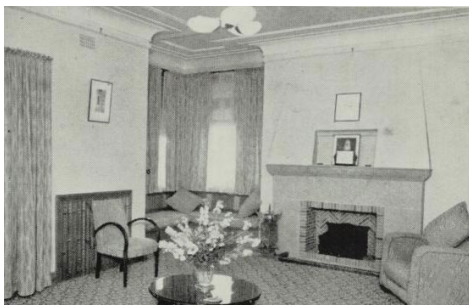
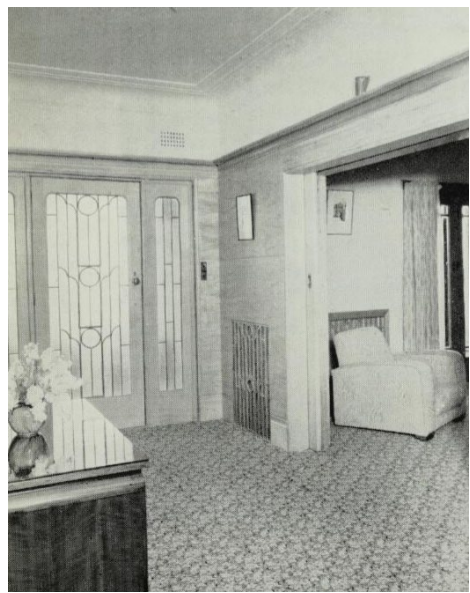
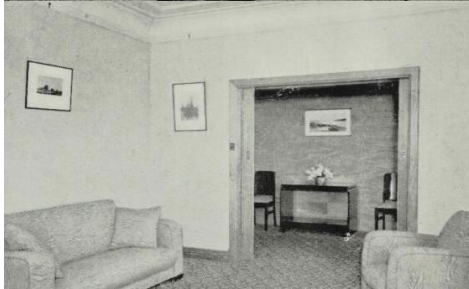
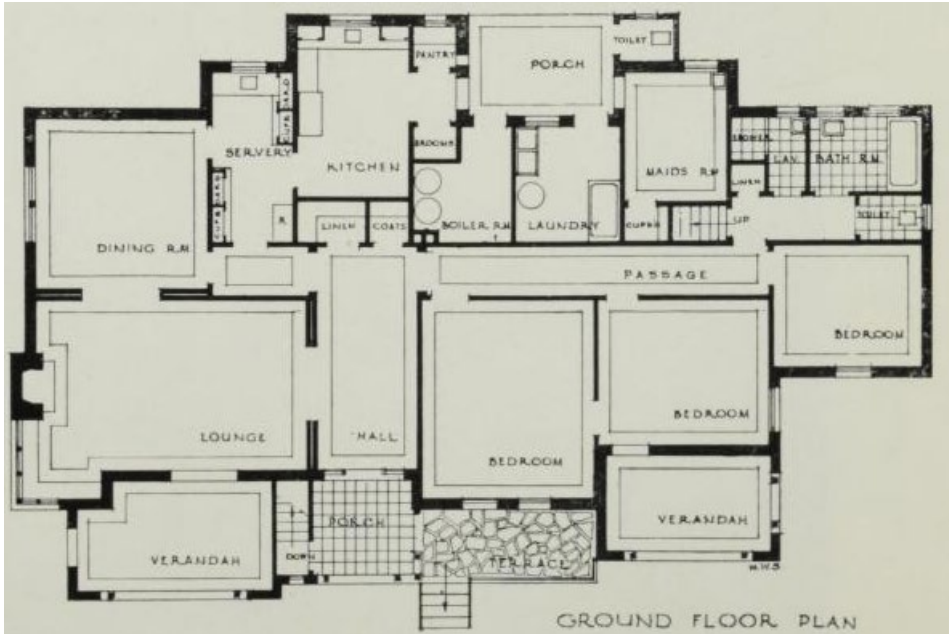
9 Photographs of the exterior and interior of the house and ground floor plan shortly after completion.

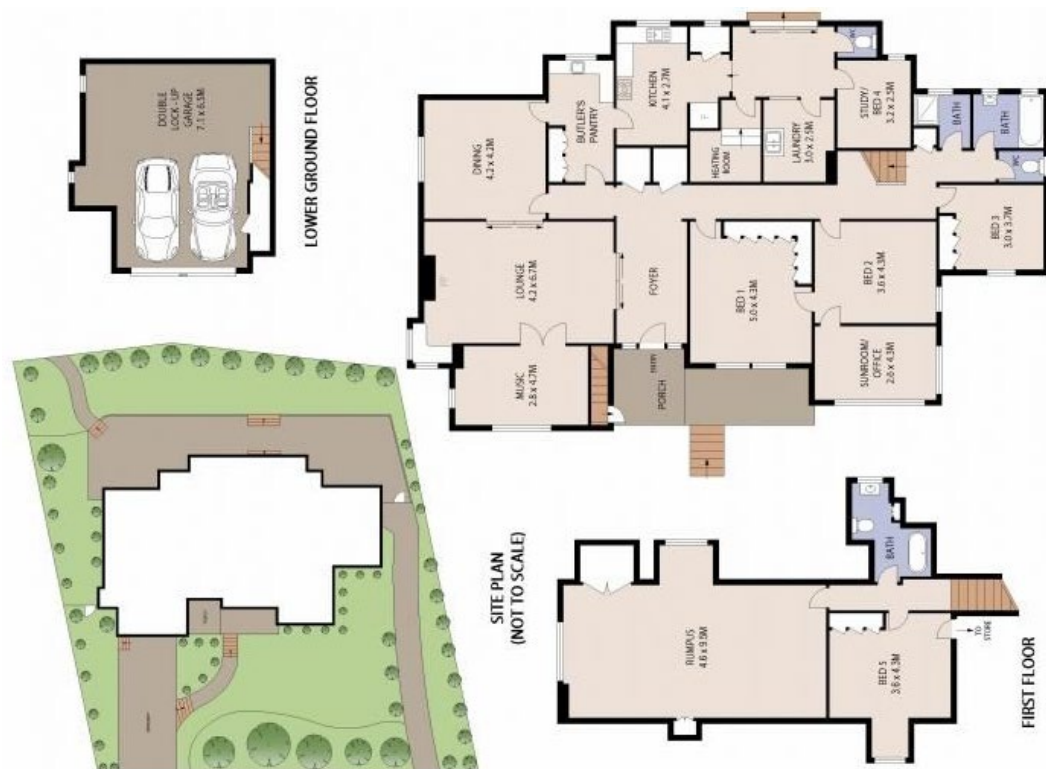
When the house was listed for sale in January 2012, its layout and interior features were substantially intact, as reflected in the floorplan and images below. The two front verandahs had been enclosed as sunrooms by this time, but likely earlier.

10 Real estate floorplan as of January 2012.  
Source: Domain Real Estate

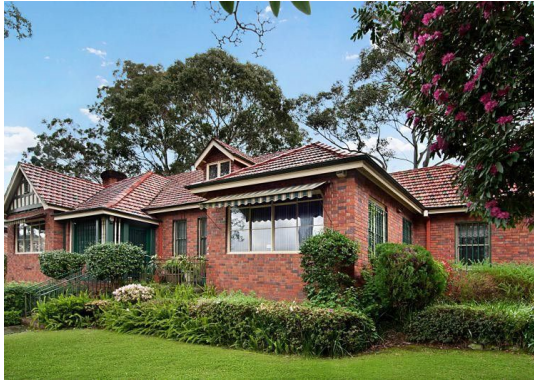
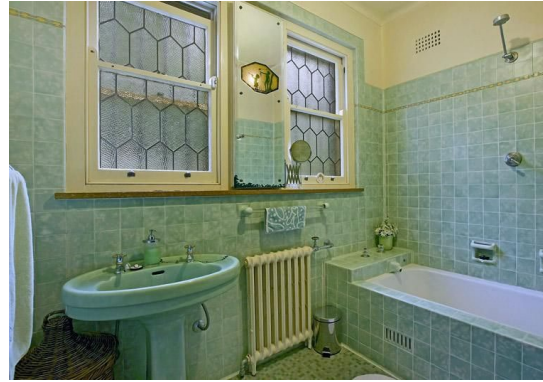
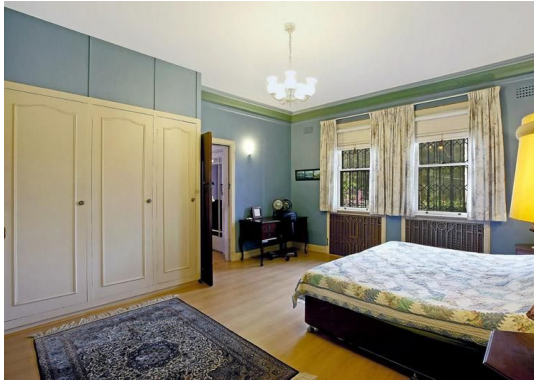
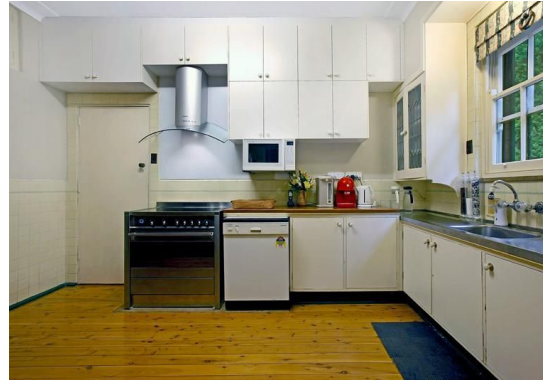
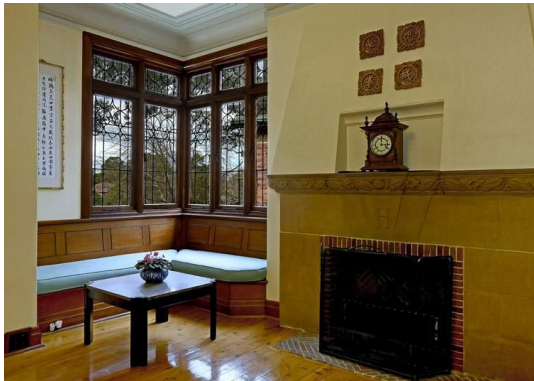
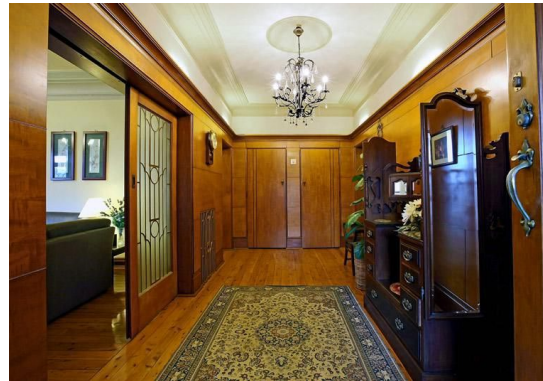
11 Photographs of the house as of January 2012.  
Source: Domain Real Estate

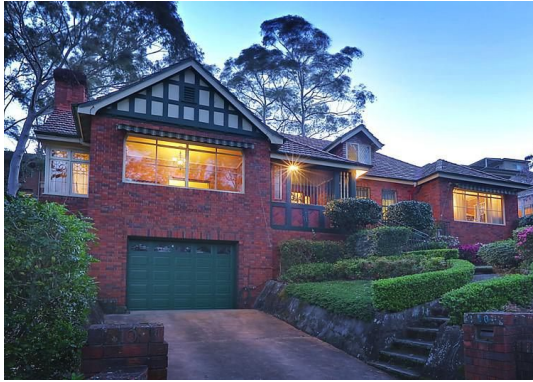
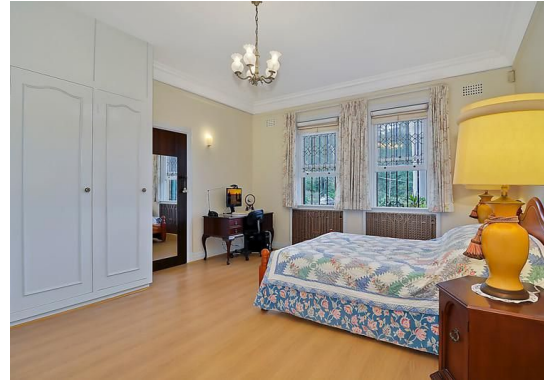
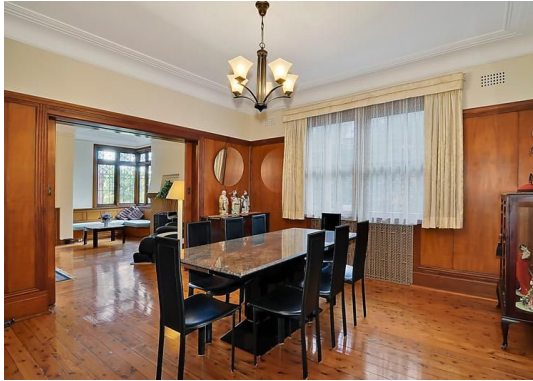
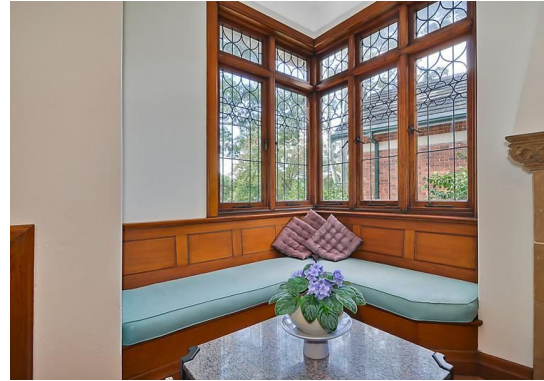
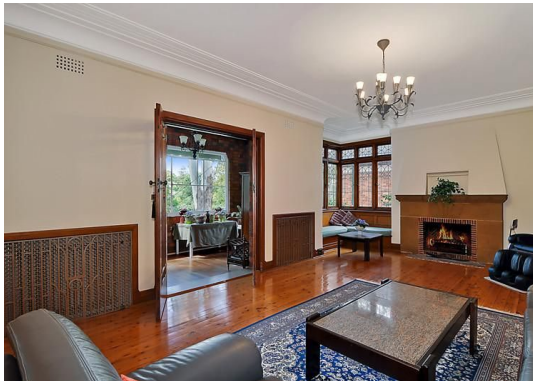
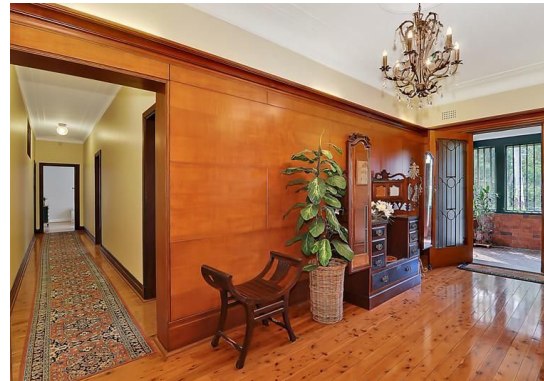
The house was advertised for sale again in 2013. Besides minor changes to interior finishes little appears to have changed in this period.

12 Photographs of the house as of May 2013.  
Source: Domain Real Estate

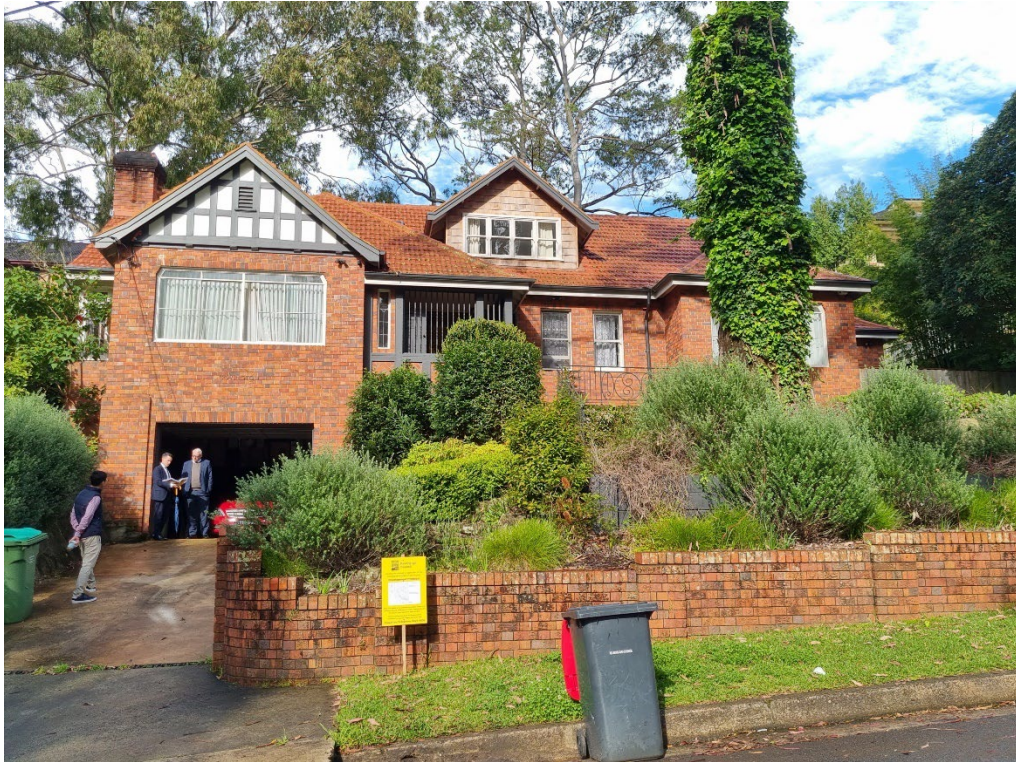
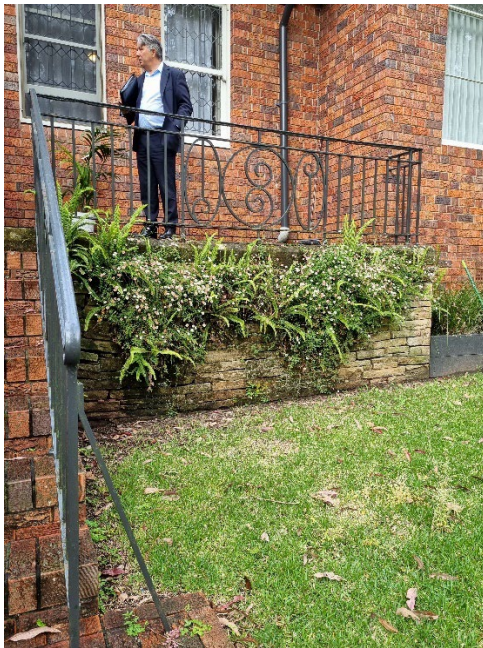
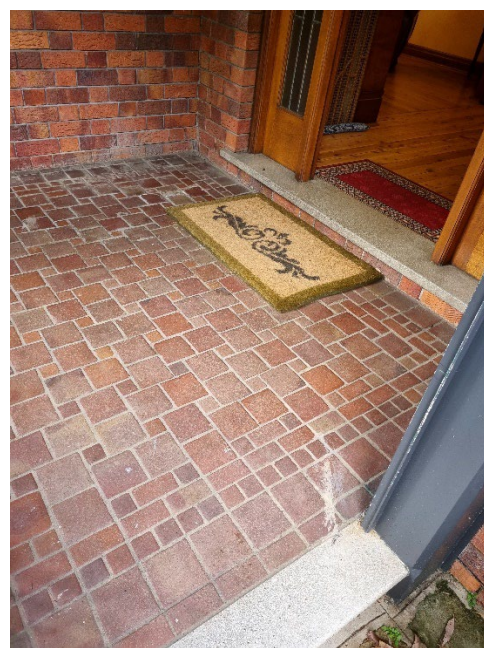
13 Exterior views of 10 Park Crescent. Above: As viewed from the street.  
Below: (L) detail of brick steps, stone terrace and wrought metal balustrade. (R) Tiles to porch, matching what contemporary sources describe as 'Dutch' terracotta/clay floor tiles.  
Source: TKD Architects

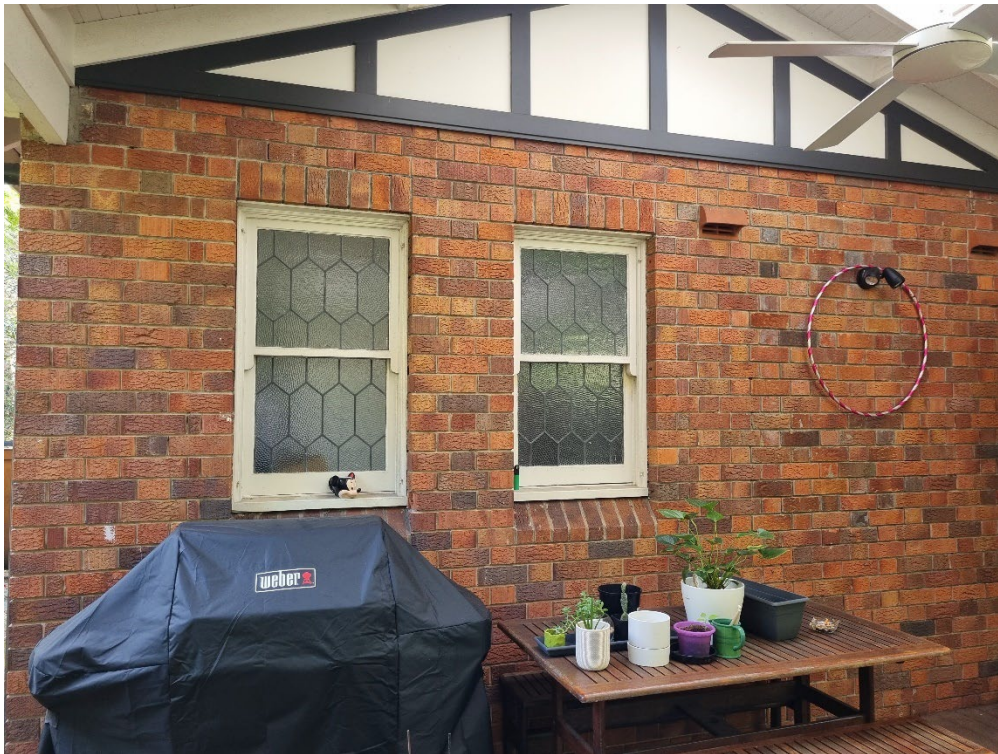
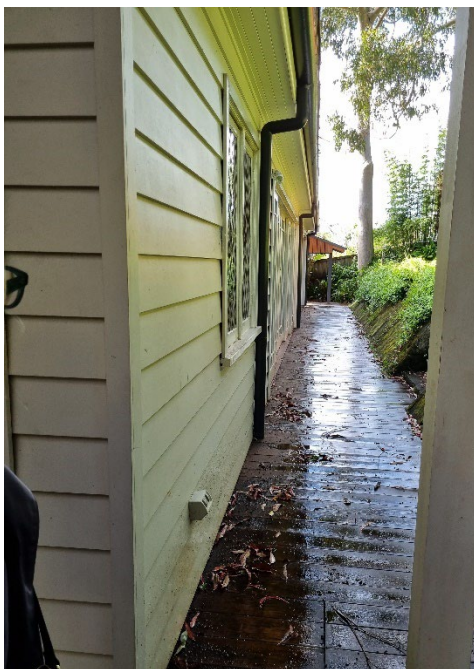
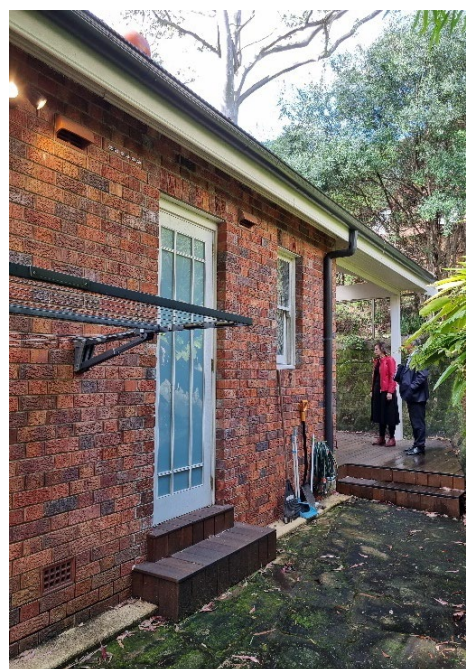
14 Exterior views of 10 Park Crescent, as viewed from rear. Above: Original windows at north end of rear elevation, with new roof above. Below: (L) New extension clad in painted timber and modern timber deck. (R) North elevation of house (new door in place of former window opening, and new window, with simple sill detail distinguishing it from the sloping sill bricks in original window openings).  
Source: TKD Architects

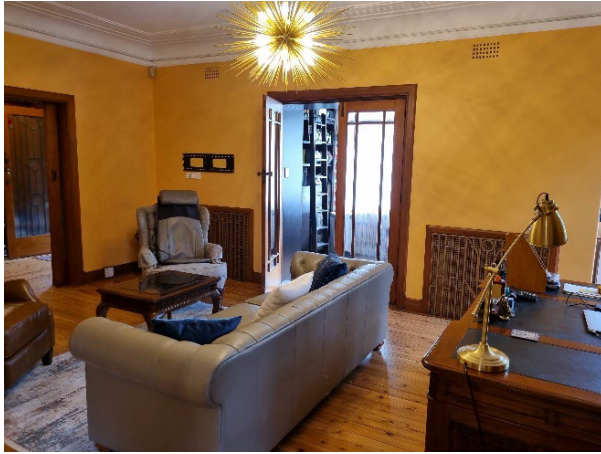
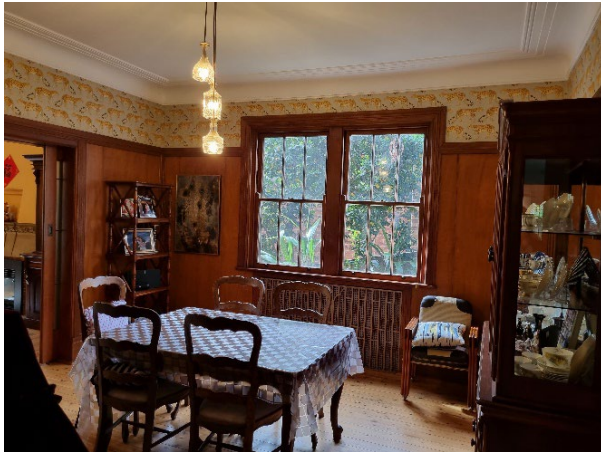
16 Interior views of house, top to bottom: Original lounge room, original dining room, and extended dining area to rear with exposed brickwork panel

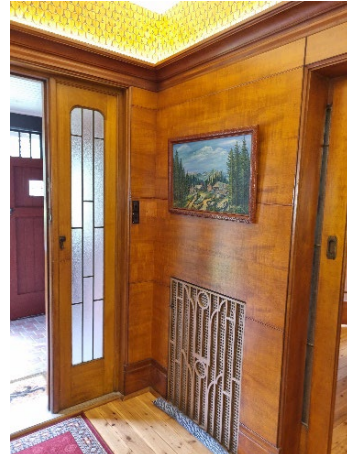
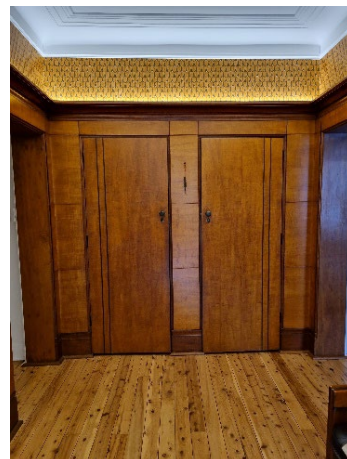
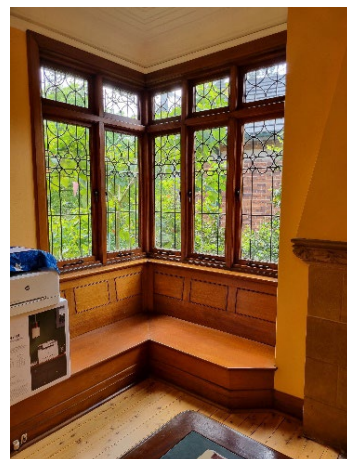
17 Interior views of house, top to bottom: Entry Hall showing electro-plated copper sidelight, extensive timber panelling and decorative grilles to radiators; built-in timber panelled cupboards in hall; and built-in timber panelled seat in dining room.

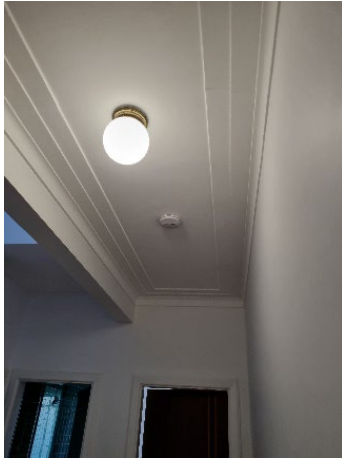
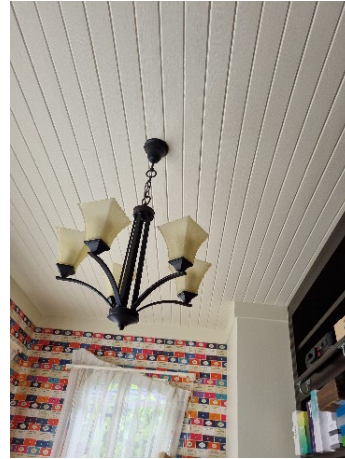
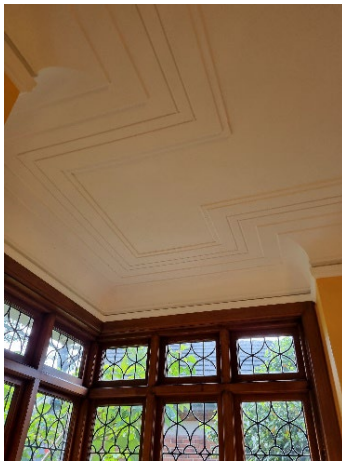
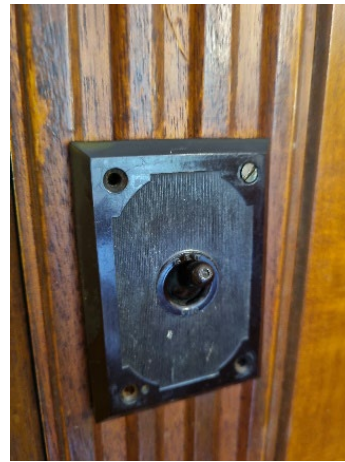
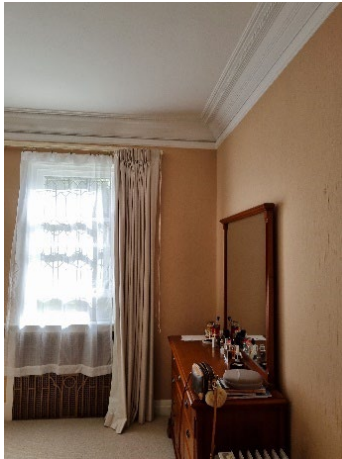
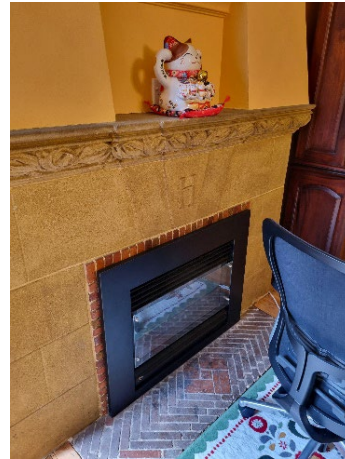
18 Interior views of house, top to bottom: original ceiling and cornice details to passage, lounge room and master bedroom.

19 Interior views of house, top to bottom: Verandah ceiling lining boards (appear original) in now enclosed verandah, example of 1930s light switch in dining room, and synthetic stone fireplace with 'H' for Herriott and Australian floral motifs.

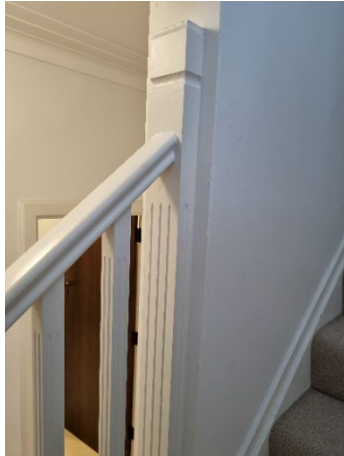
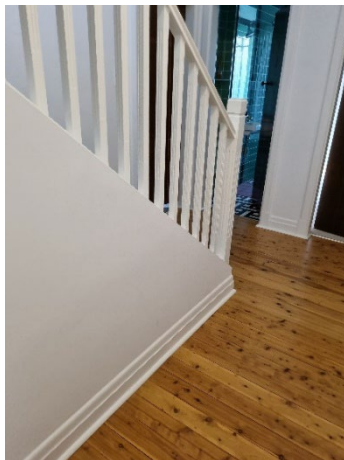
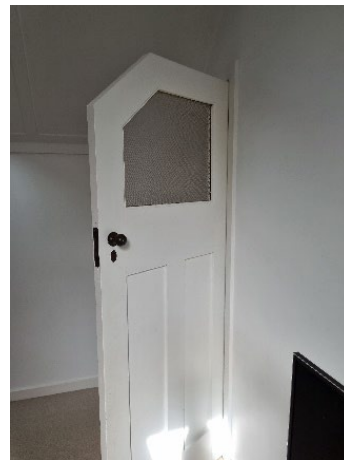
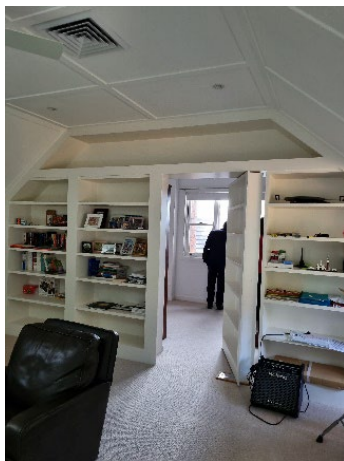
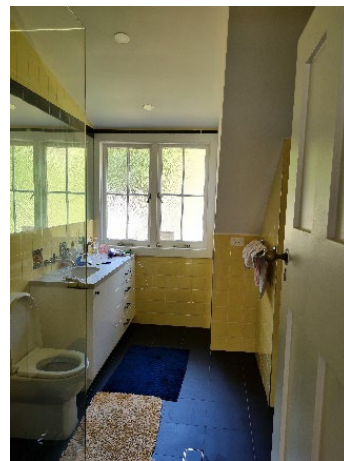
20 Interior views of house, top to bottom: stair (appears original to 1936), stair and skirting to stair, view of attic space toward extension showing battened ceiling (appears original).

21 Interior views of house, top to bottom: two examples of original joinery within attic (first being a Beale & Co. door), and attic bathroom (provenance unknown)

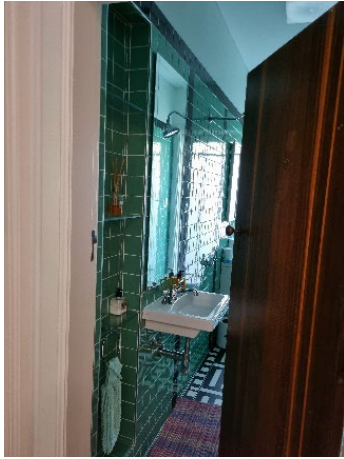
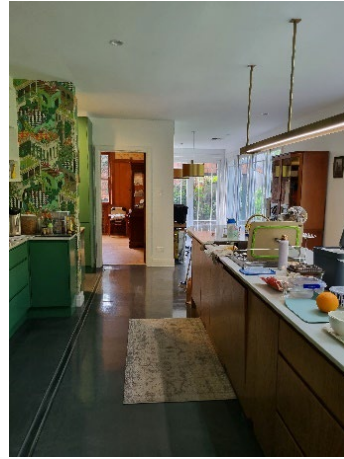
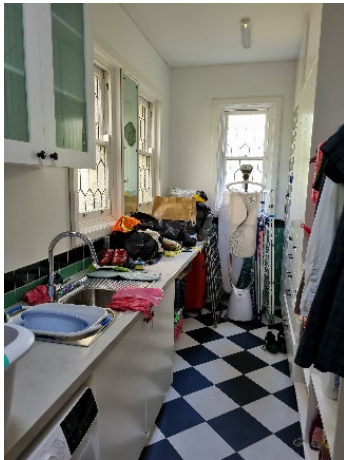
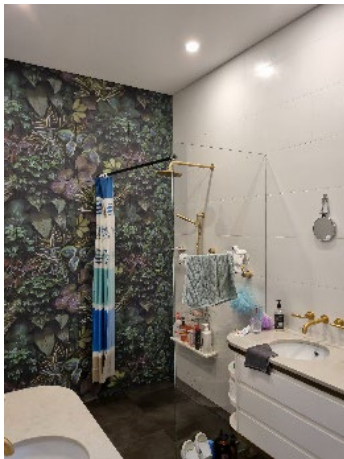
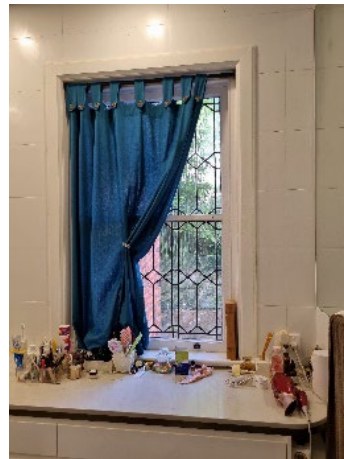
22 Interior views of house, top to bottom: Modern bathroom in place of former bathroom behind original door, modern laundry in location of former bathroom (original windows visible and cabinet salvaged from original bathroom), modern fitout to new bathroom.

23 Interior views of house, top to bottom: View within modern kitchen looking toward dining room, view of original (relocated) door to laundry within family room (with under stair room to right), and original window within new bathroom (in divided bedroom).

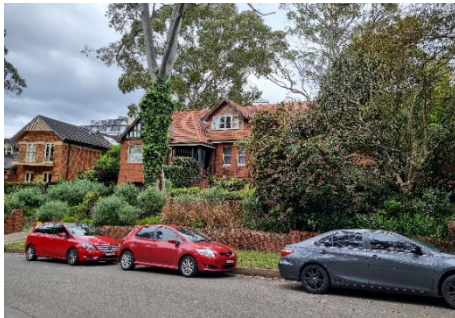
24 View of front garden, split level somewhat obscured by plantings.

The broader site retains evidence of its original planning in the split-level front garden and rear yard. The original brick front fence is retained with its 'front' and 'tradesman's' entrances though gates appear to have been removed. The sandstone bank, steps and path up to the house from the driveway, the concrete path and steps from the tradesman's entrance, and the stone terrace, bank and steps at the rear of the site also survive. The stone bank at rear features built in planters. The rockery in the front garden has been removed, with the split-level space now filled with a variety of low plantings. A large mature tree, planted in the mid to late twentieth century, is also present. At the rear there is a small cubby house atop the bank, and a gazebo structure to the southern end of the rear deck, both having been installed in recent decades. The house also retains its important relationship to the nearby Robert Pymble Park on the opposite side of Park Crescent, which it was designed to face and capture views of.

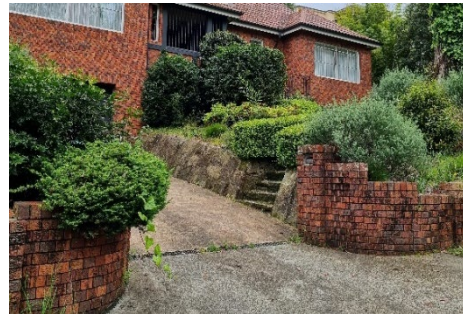
25 View of brick fence and main entrance, stone bank and steps up to house.

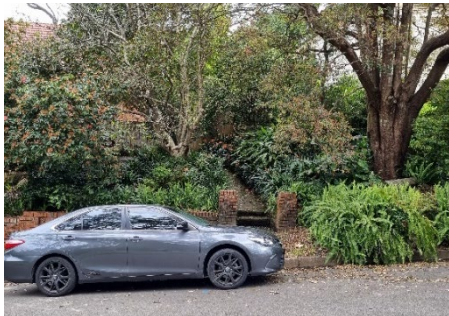
26 'Tradesman's' entrance and concrete steps and path.

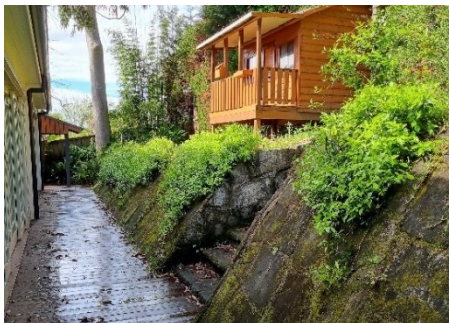
28 Original stone bank to rear and steps.

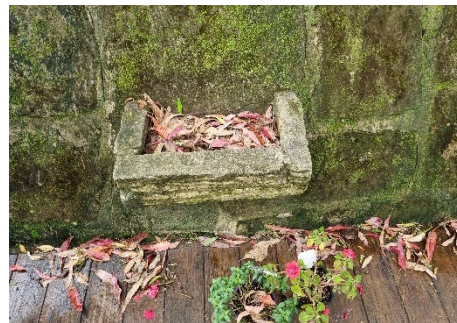
29 Inbuilt planters to stone bank.

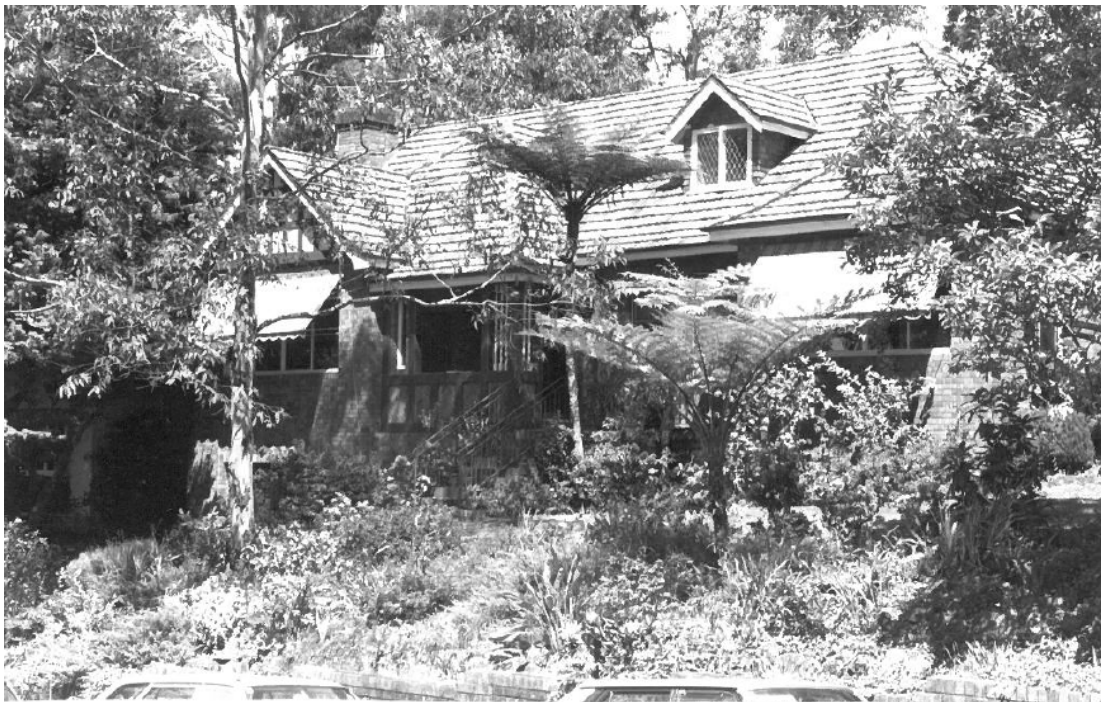
31 The building as pictured in the 1989 Heritage Study.  
Source: Ku-ring-gai Library - Local Studies

The original inventory sheet for 10 Park Crescent was prepared in December 1986 and completed by Heritage Architect Robert Moore. The original heritage listing of the place was based on this sheet, which provided limited details typical of the large drive-by heritage studies of this period. The inventory sheet identified the reasons for listing as related to the architectural value of the place. The contribution of the garden to its aesthetic values were also noted. The item was identified as illustrating the suburban consolidation of the area, and its integrity given as substantially intact.
